PENTAGON RENOVATIONS – EXTERIOR WALL REPAIR & INTERIOR STRUCTURAL REPAIR

Concrete Repair Bulletin *November / December 2009*

THE PENTAGON

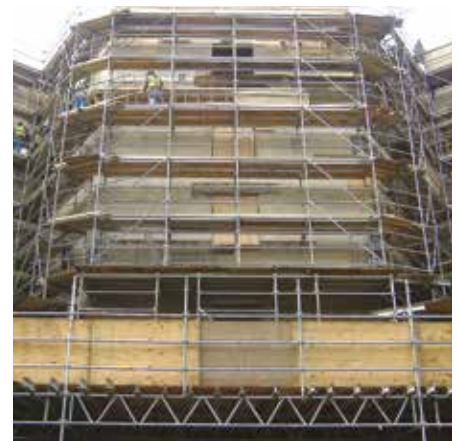
Repair crews working on Pentagon walls

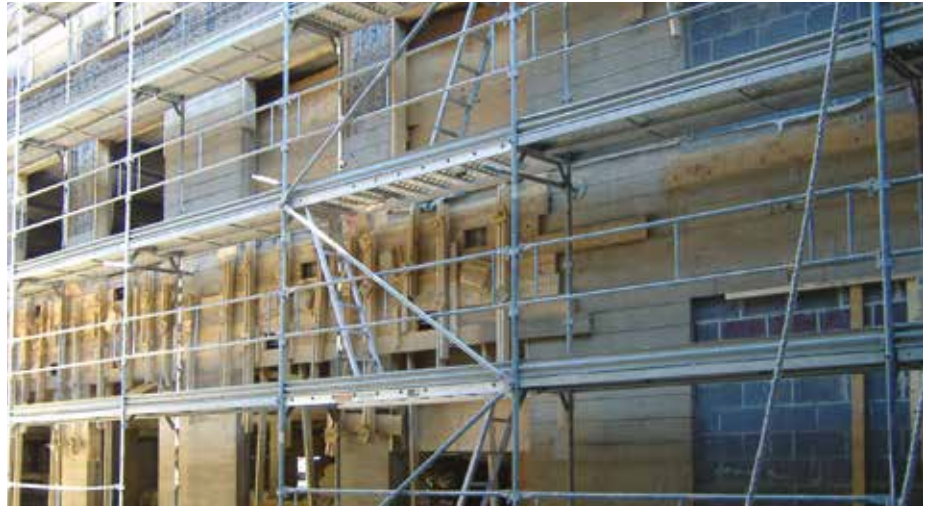
Work area showing extensive scaffolding

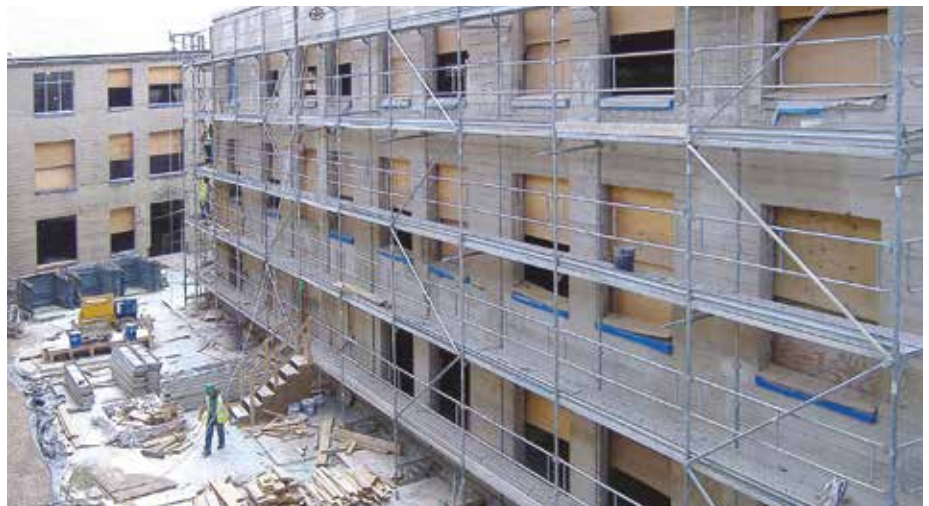
Through visual inspection, the lightwell walls indicated telltale signs of concrete spalling and exposed reinforcing steel corrosion. Exposed reinforcing steel was observed at many locations on the lightwell wall finished

surfaces. Reinforcing steel ends, chair legs, and tie wire were on the exterior formed surfaces and exposed to the elements. Initially, it was estimated that approximately 20 to 30% of the exterior wall was in need of repair.

View of interior lightwell work area

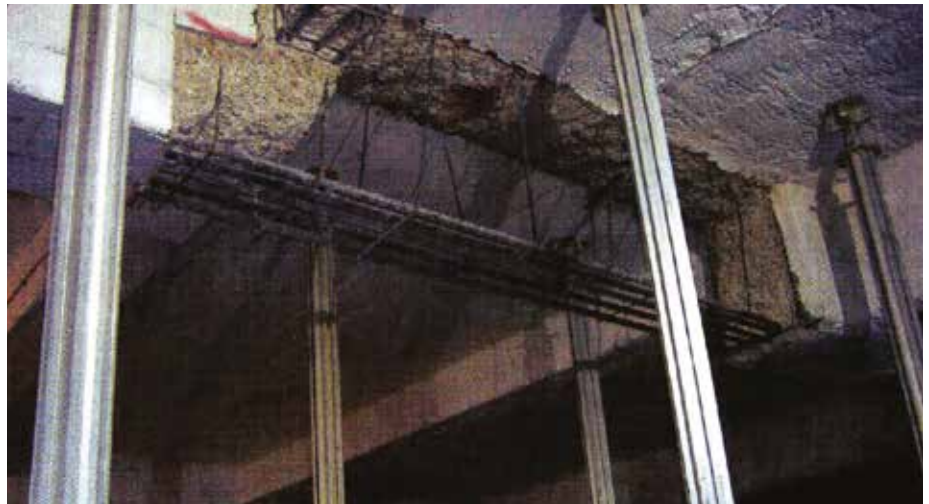
Interior beam repair work – notice the extensive shoring

The lightwell walls were not the only concrete at the Pentagon in need of protection and restoration. Following asbestos and lead abatement, the interior finishes were removed to bare concrete, revealing a structure in distress. The inspecting engineering agency then sounded the concrete structural system components and marked areas that required repair. Some repairs included fulldepth

column and beam repairs requiring the use of extensive shoring. As with the exterior lightwell repairs, the large repairs were formed and placed, and the small interior repairs were placed with the hand-applied method.

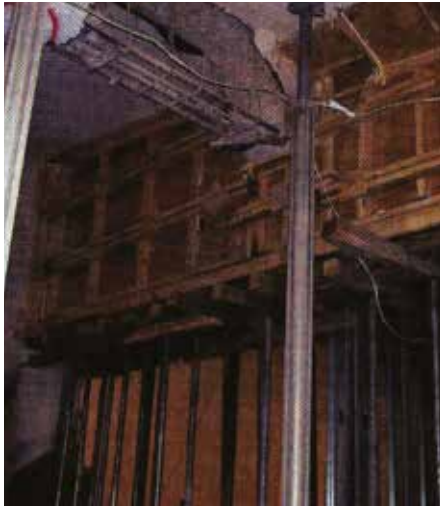
View of the full-depth beam repair

In one particular area, the removal of the interior finishes uncovered a large section of the second floor structure that had been damaged by an historical fire. This unexpected repair required fulldepth removal of beams and girders, some more than 4 ft (1.2 m) deep. After the floor slab was extensively shored, the damaged concrete was removed, the beams were formed, and ready mixed concrete was placed from the above level.

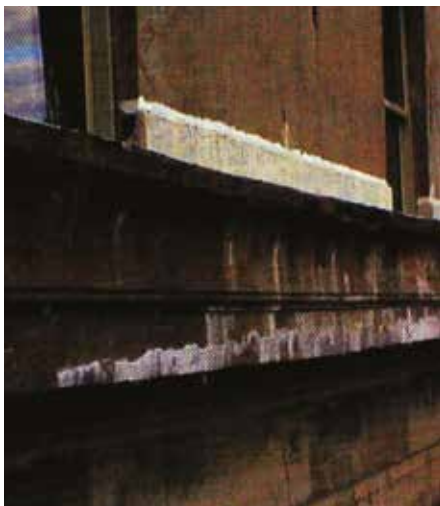
Close-up of repaired area on walls: before

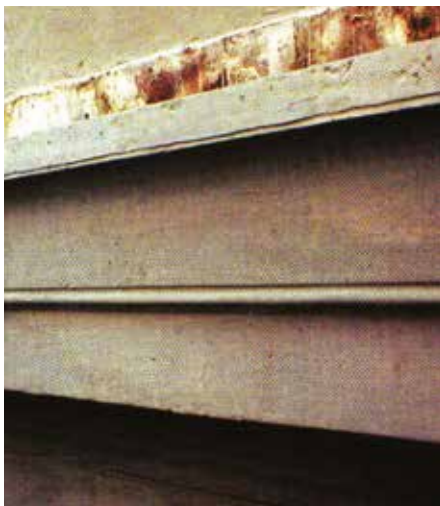
Close-up of repaired area on walls: after

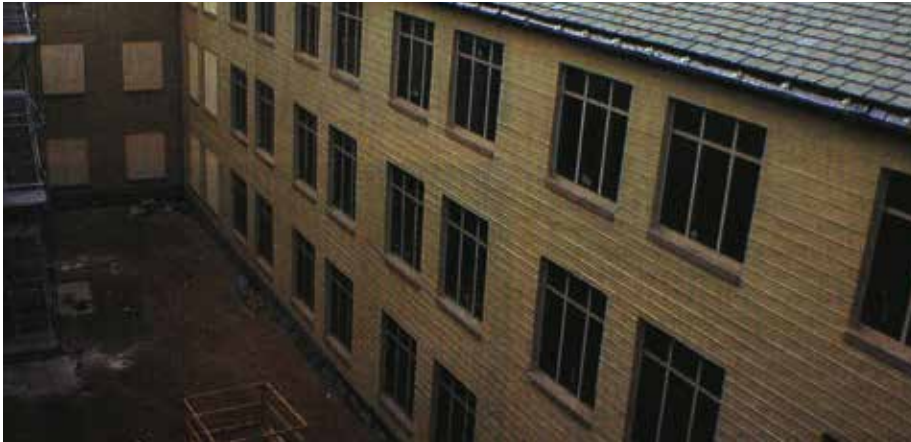
Completed repairs

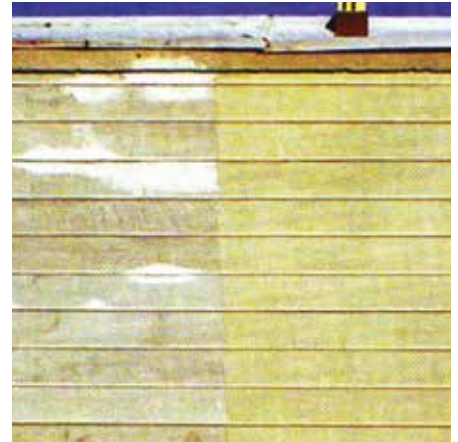
Before and after coating application

- A mineral-based coating was applied to provide a preventative waterproofing for the unrepaired concrete areas, protect the new repairs, act as further prevention against water absorption, and give the building a uniform appearance. This potassium silicate coating was chosen to form a chemical bond with the concrete, yet allow the cast-in-place structure to breathe and be permeable. The coating system chosen is high in pH to protect the reinforcing steel and concrete from carbonation.
