PENTAGON RENOVATIONS – EXTERIOR WALL REPAIR & INTERIOR STRUCTURAL REPAIR

Concrete Repair Bulletin November / December 2009

THE PENTAGON

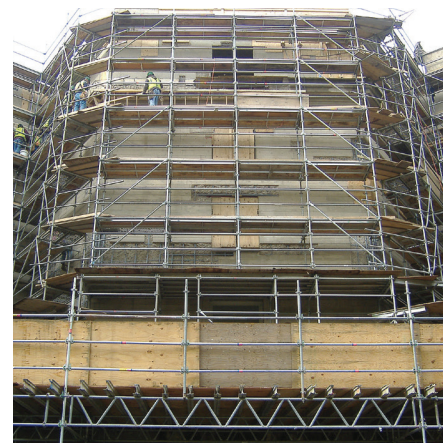
Repair crews working on Pentagon walls

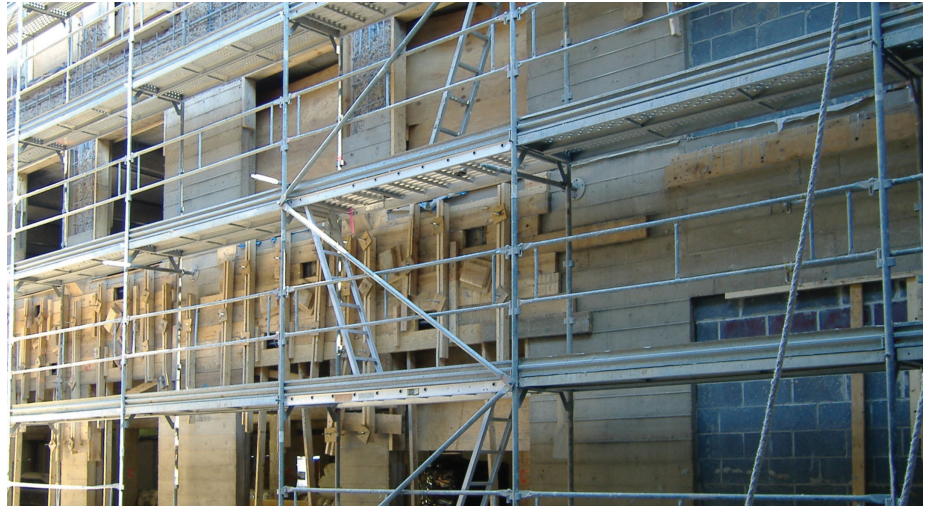
Work area showing extensive scaffolding

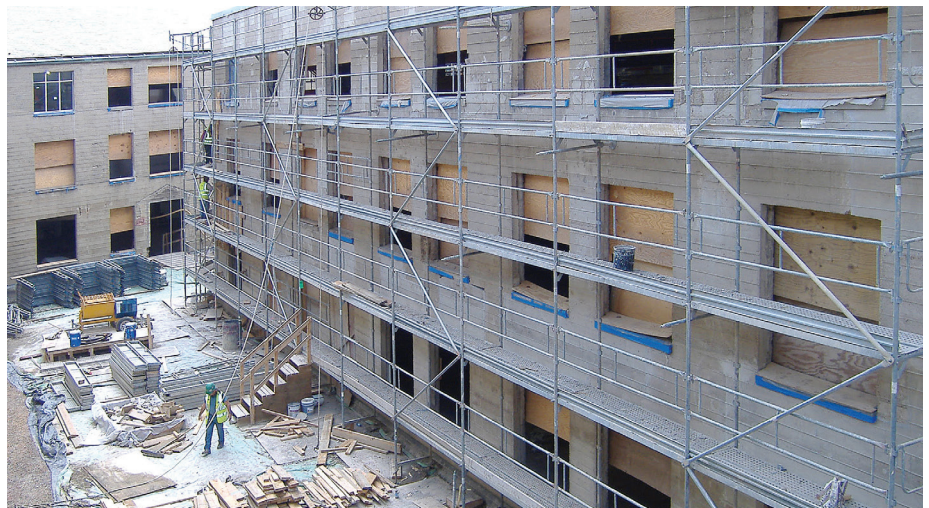
Through visual inspection, the lightwell walls indicated telltale signs of concrete spalling and exposed reinforcing steel corrosion. Exposed reinforcing steel was observed at many locations on the lightwell wall finished

surfaces. Reinforcing steel ends, chair legs, and tie wire were on the exterior formed surfaces and exposed to the elements. Initially, it was estimated that approximately 20 to 30% of the exterior wall was in need of repair.

View of interior lightwell work area

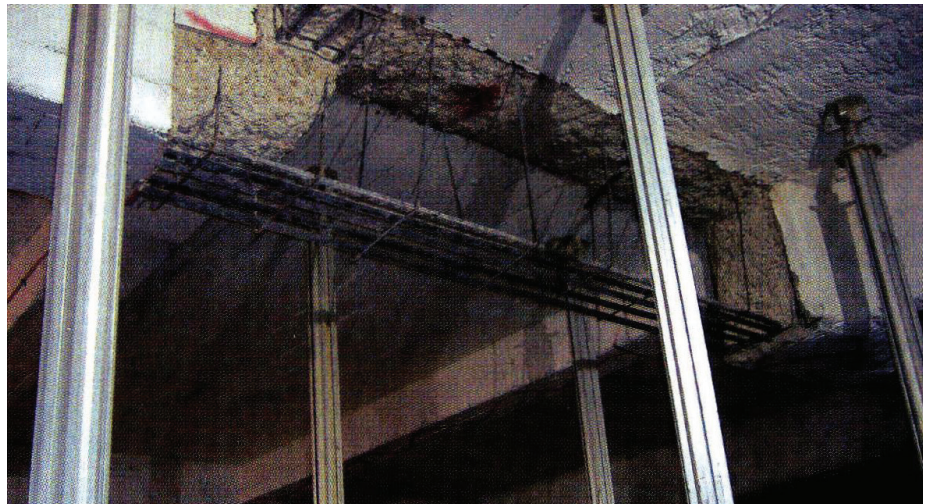
Interior beam repair work – notice the extensive shoring

The lightwell walls were not the only concrete at the Pentagon in need of protection and restoration. Following asbestos and lead abatement, the interior finishes were removed to bare concrete, revealing a structure in distress. The inspecting engineering agency then sounded the concrete structural system components and marked areas that required repair. Some repairs included fulldepth

column and beam repairs requiring the use of extensive shoring. As with the exterior lightwell repairs, the large repairs were formed and placed, and the small interior repairs were placed with the hand-applied method.

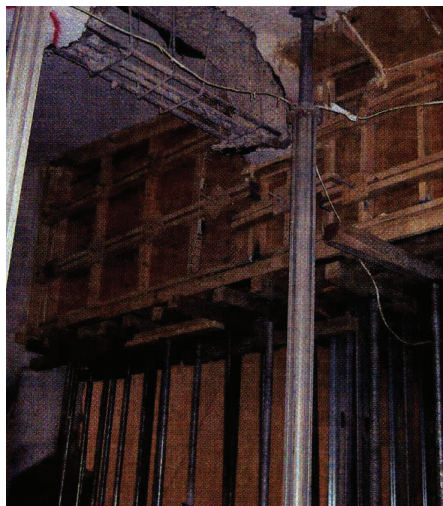
View of the full-depth beam repair

In one particular area, the removal of the interior finishes uncovered a large section of the secondfloor structure that had been damaged by an historical fire. This unexpected repair required fulldepth removal of beams and girders, some more than 4 ft (1.2 m) deep. After the floor slab was extensively shored, the damaged concrete was removed, the beams were formed, and ready mixed concrete was placed from the above level.

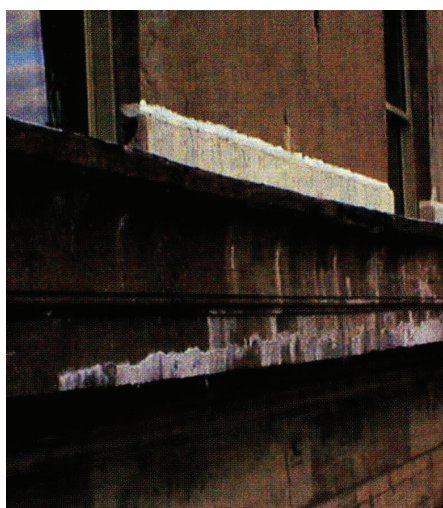
Concrete testing performed revealed that the existing concrete walls were carbonated to a depth of 3 to 4 in. (76 to 102 mm). Destructive testing revealed that during construction, the outer layer of wall reinforcing was placed approximately 1/2 in. (13 mm) from the finished exterior surface. The improper placement of the reinforcing steel was mainly due to the fast-paced construction of the Pentagon. The reinforcing steel placement and wooden forms were not coordinated to ensure proper coverage. The rough-cut board forms exaggerated this condition by not providing a uniform surface exterior to the steel. The improper placement of the reinforcing steel, coupled with the years of

carbonation, has created an environment ideal for corrosion.

As carbonation lowers the alkalinity of the concrete, it causes a loss of the reinforcing steel's natural protection from corrosion. Furthermore, the exterior finished surface of the concrete is very porous as a direct result of the rough-cut lumber formed surface and the low concrete strength. Moisture is easily absorbed into this porous surface every time it rains. With the carbonation being well below the threshold limit, corrosion was induced; and the unprotected reinforcing steel began to oxidize.

Close-up of repaired area on walls: before

- In areas of inadequate cover, the concrete was undercut and the reinforcing bar was recessed to provide a minimum of 1-1/2 in. (38 mm) cover; and

- After sandblasting, a corrosion inhibiting coating was applied to the reinforcing.

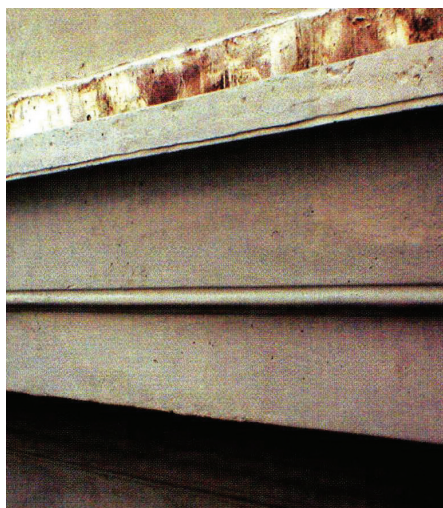
Close-up of repaired area on walls: after

To accomplish these tasks, the contractor worked with the material supplier to develop a custom repair concrete that matched the strength and color of the existing material. Full-scale mock-ups and laboratory analysis were conducted to ensure the material met all of the requirements. This material was developed in two formulations: one was pumpable for larger repair areas and the other was trowelable for the minor amount of hand patching on smaller repair areas. To meet the specification requirements that the repairs are not detectable from a distance of 30 ft (9 m), the contractor used rough-cut lumber to match the texture of the original surface. Each board was cut specifically to match the varying widths of the existing wall, and the edges were beveled to create the “ribbed” finish.

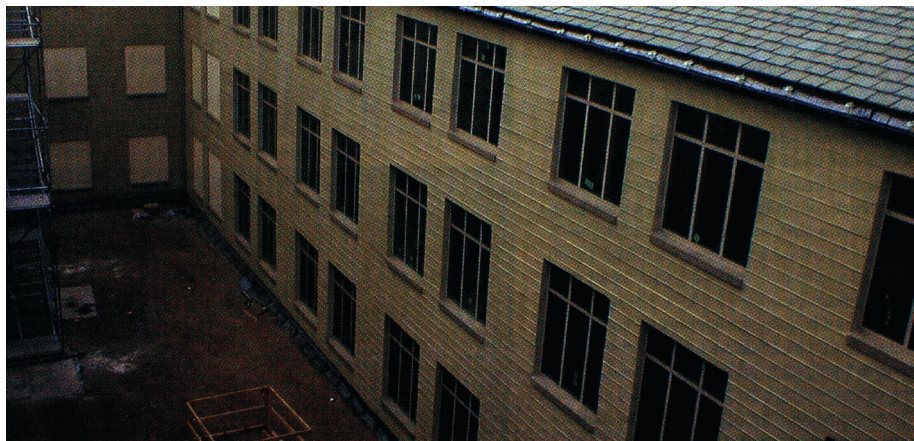
Completed repairs

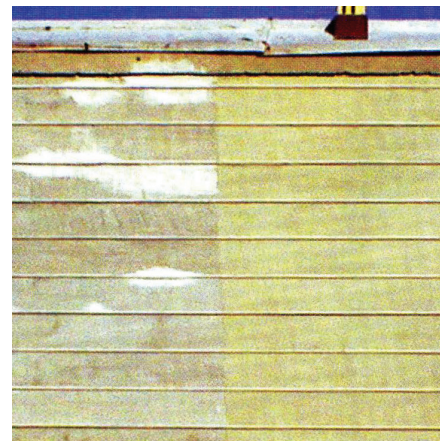
Before and after coating application

- A migrating corrosion inhibitor, selected to compensate for the loss of alkalinity around the reinforcing steel, was applied to the entire wall surface. This amino-based migrating inhibitor was topically applied to the concrete surface, and this water-based inhibitor penetrates the concrete's pore structure through capillary action, causing it to diffuse throughout the concrete molecular matrix. Furthermore, the amino molecules have an ionic reaction with the reinforcing steel, causing a physical attraction creating a tenacious bond to the reinforcing steel, and thus recreating a passive layer of high alkalinity;

- After the application of the migrating corrosion inhibitor, a 100% silane sealer was applied to the walls to repel water and reduce moisture absorption; and

- A mineral-based coating was applied to provide a preventative waterproofing for the unrepaired concrete areas, protect the new repairs, act as further prevention against water absorption, and give the building a uniform appearance. This potassium silicate coating was chosen to form a chemical bond with the concrete, yet allow the cast-in-place structure to breathe and be permeable. The coating system chosen is high in pH to protect the reinforcing steel and concrete from carbonation.
