National University College, Arecibo Campus Parking Structure

Structural Repairs on the Arecibo Campus Completed Months Ahead of Schedule

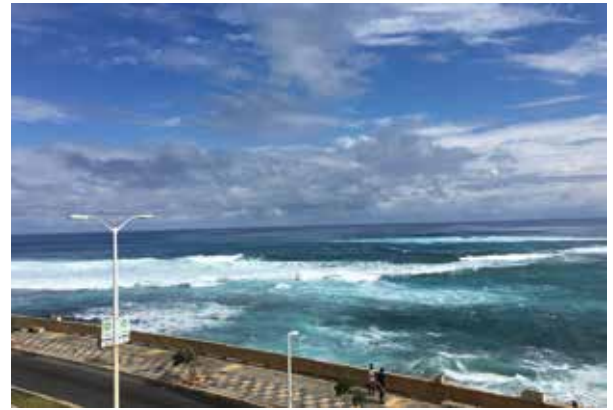
National University College in Puerto Rico has five campuses conveniently located throughout the island. The Arecibo campus sits just 50 feet from the Atlantic Ocean. Being this close to the ocean means the facility is subject to strong winds and corrosion. As a result, the campus parking structure was in dire need of structural repairs.

The campus sits 50 feet from the Atlantic Ocean and is subject to strong winds and corrosion

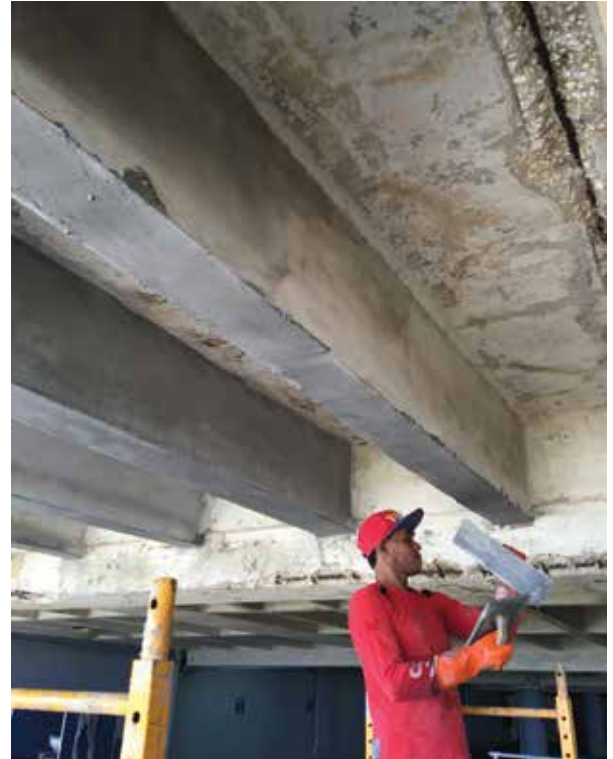
A structural engineer inspected and found more damage than expected on the parking structure's beams and columns. This was due, in part, to insufficient concrete coverage on the beams' bottom reinforcement bars. The solution was to use both partial-depth and full-depth concrete repair methods with rebar replacement. Because the Rapid Set products can be applied at thicknesses up to six inches, the repair crew was

The crew removed the top damaged slabs and replaced it with V/O Repair Mix.

For partial-depth repairs, the crew removed the top one-third of damaged slabs and replaced it with V/O Repair Mix. The high-performance, polymer-modified blend of hydraulic cement, additives and specially graded fine aggregates bonds well with existing concrete and is corrosion-resistant. The repair material is ideal for general concrete repair, resurfacing, mortar beds, and vertical and overhead applications where rapid strength gain, high durability and low shrinkage is required.

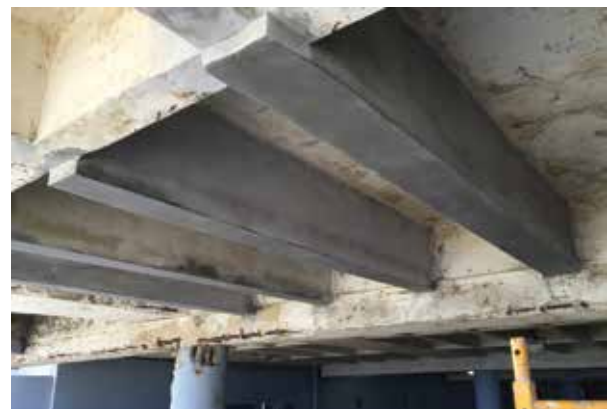
The repair material is ideal for vertical and overhead applications.

The contractor used Mortar Mix for all full-depth repairs. Used for vertical and overhead applications, the high-performance blend of hydraulic cement and quality sand is durable in wet environments, sets in 15 minutes and is ready for traffic in one hour. However, because work took place during temperatures that ranged in the mid-80s, the crew added one packet of SET Control® and three packets of FLOW Control® to every 55 pounds of Mortar Mix to keep the material from setting too fast. The SET Control additive slows setting times during warmer temperatures while Flow Control increases fluidity of the mixture. Additionally, replacing water in the mix with FLOW increases strength and reduces shrinkage.
