# Shrinkage-Compensating Concrete in Post-Tensioned Buildings

A Four-Building Survey – Part One

By Kenneth B. Bondy, S.E., FACI

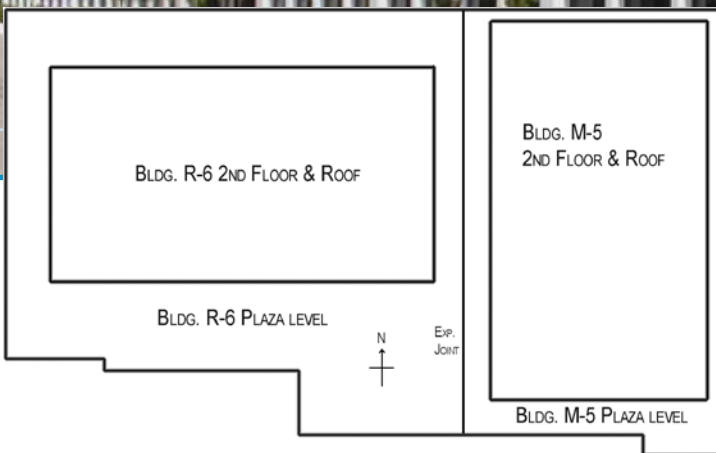
*Buildings M5 and R6 (plan view). These two buildings required elevated concrete decks with no control joints or pour strips. Shrinkage-compensating concrete was successfully used to cast all floor members. The buildings continue to perform well more than 40 years later. Courtesy of CTS Cement Mfg.*

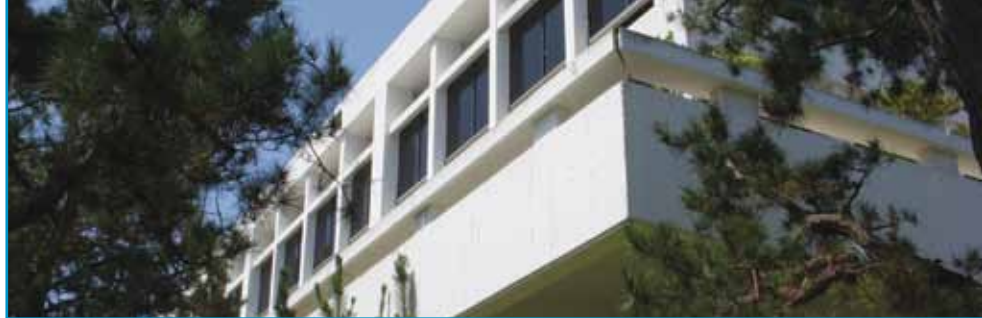
Building M5, southeast corner showing dramatic cantilevered post-tensioned beams at Plaza Level. Courtesy of Phillip Yee of Northrop-Grumman.
