## A PERFECT MATCH

### *Post Tensioning and Shrinkage Compensating Concrete Form a Durable Union at John Wayne Airport*

MICHAEL CHUSID, RA FCSI

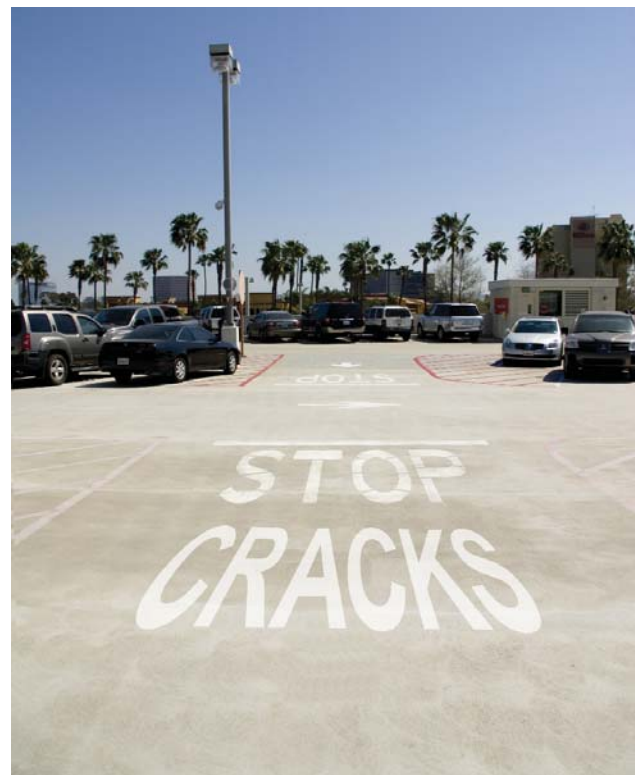
Fig. 1 - Large post-tensioned slabs without drying shrinkage cracks are possible. All you need is the right concrete.

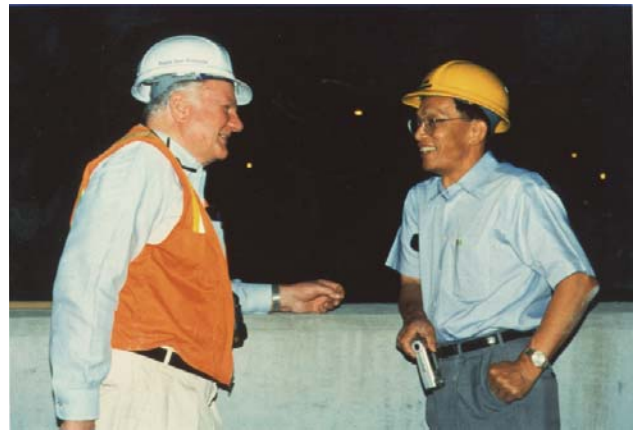
Fig. 4 - Teng Li (right) on the jobsite during a night-time pour in 1998 with Edward Rice, one of the original developers of shrinkage compensating concrete and 2005 recipient of the PTI "Legends of Post-Tensioning" award.

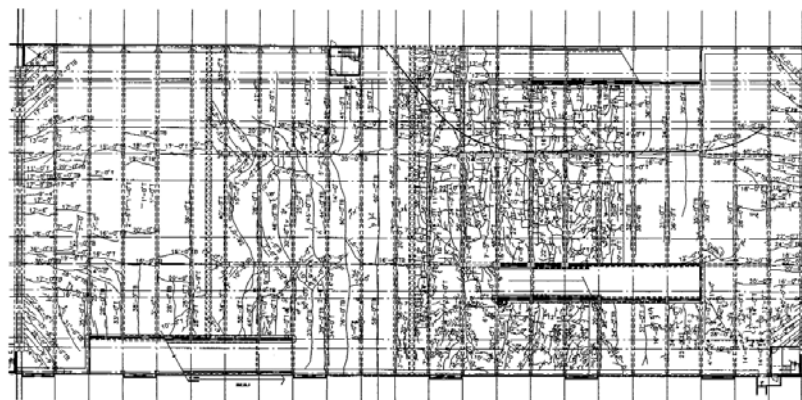
Fig. 5 - When Teng Li began work on the new addition, he made a complete crack-map of the existing structure. He calculated that there were nearly two inches of shrinkage cracks per square foot of the conventional concrete deck.  
*Courtesy of Teng Li & Assoc.*

Parking structures A2 and B2 are free-standing buildings opposite the airport's main terminal. Begun in the early 1990s, construction of Level 0, a below ground-level slab-on-grade, went smoothly. However, when slabs were poured for Level 1, they immediately began to crack severely. The 479,700 square feet of deck had approximately 70,000 linear feet of cracks, more than a foot of cracks for every seven square feet of deck. The cracks are not just surface cracks; many are visible from the underside where the deck forms the ceiling of Level 0.

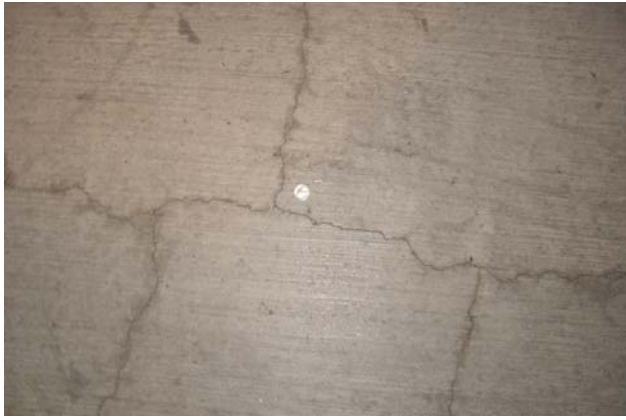
Fig. 6 - When the original structure was built, the slabs - made with portland cement concrete - exhibited drying-shrinkage cracking before the concrete was strong enough for post-tensioning.

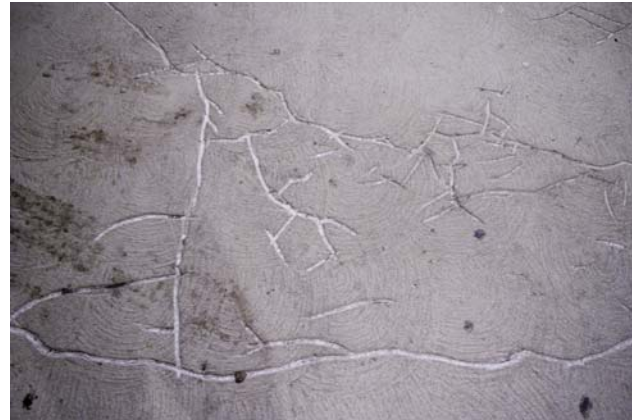
Fig. 7 - 70,000 ft of cracking in Level 1 of the original structure was routed out and sealed to eliminate water infiltrating the slabs or leaking through onto cars on Level 0 below.

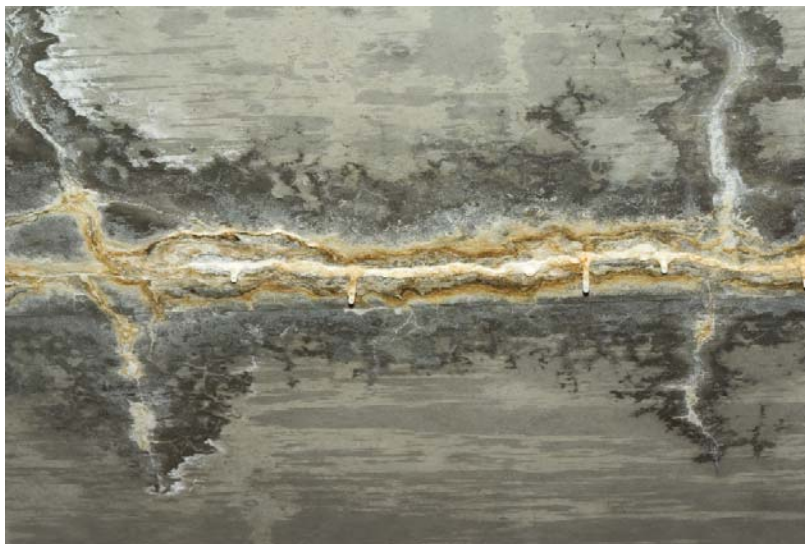
Fig. 8 - Cracks in the Level 1 deck of the original structure as seen from the underside. Water leaking through the cracks carried lime from the interior of the conventional concrete, depositing disfiguring efflorescence and dripping onto cars on Level 0.

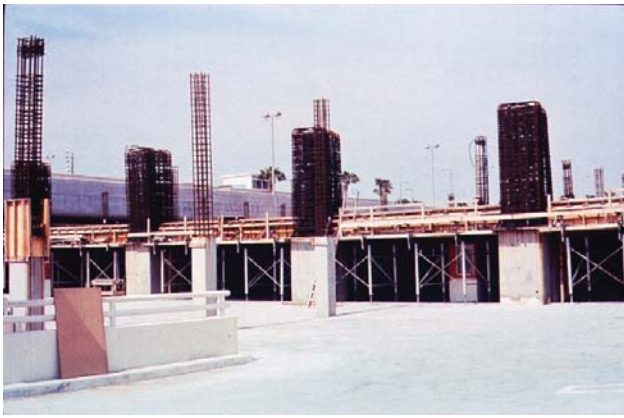
Fig. 9 - Formwork and reinforcement in place in the summer of 1998.

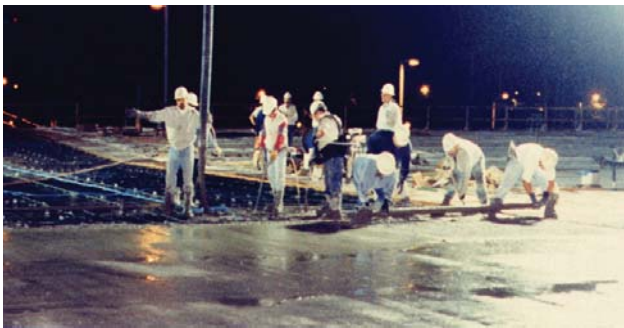
Fig. 10 - Type K concrete was placed at night to accommodate airport traffic regulations and to protect the fresh concrete from excessive summer heat.

The 46 slabs comprise 20,000 cubic yards of concrete. Due to airport traffic regulations, all the pours had to be done at night. This was actually good for the project, since temperatures below 90°F are recommended for pouring Type K concrete. Teng Li believes that the lower temperatures of night-time pouring are generally better for concrete. This idea is supported in data reported by the U.S. Department of the Interior, which shows that lower initial casting temperatures result in concrete with higher final compressive strength.<sup>1</sup> The slabs were moist-cured using wet burlap.

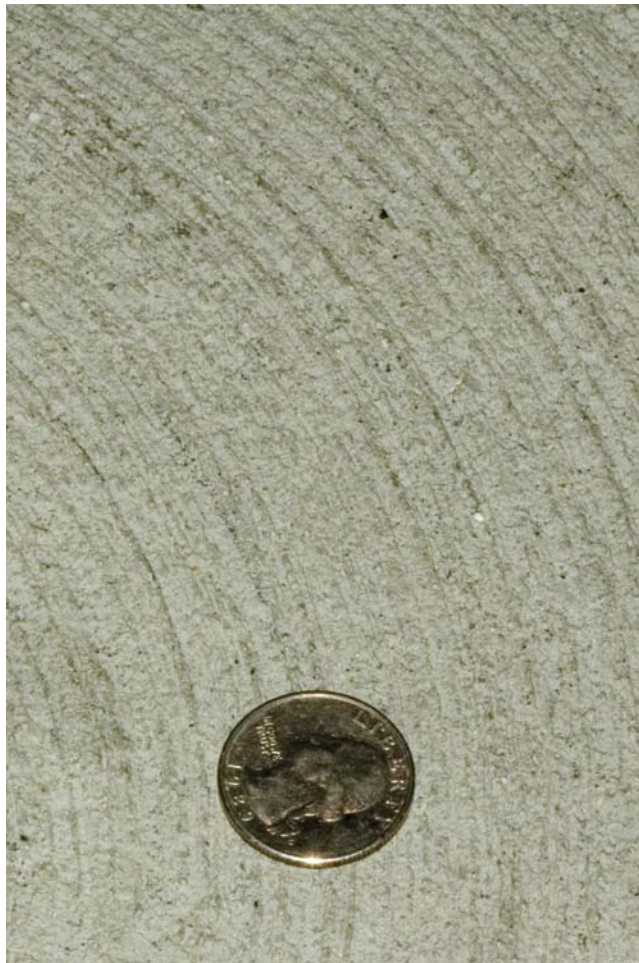
Fig. 11 - After nine years of heavy traffic, the swirled trowel-patterns on the Type K concrete on Level 2 are still crisp and looking new, due to the material's superior abrasion resistance.

Type K concrete has a stronger surface due to its high water-demand. It yields minimal bleed water, so it does not suffer from these weakening processes. The surface retains the full hardness of the mix. ACI 223 – Standard Practice for the Use of Shrinkage Compensating Concrete notes, “Shrinkage-compensating concrete, when properly proportioned and cured, has an abrasion resistance from 30 to 40 percent higher than portland cement concrete of comparable mix proportions.”<sup>2</sup>

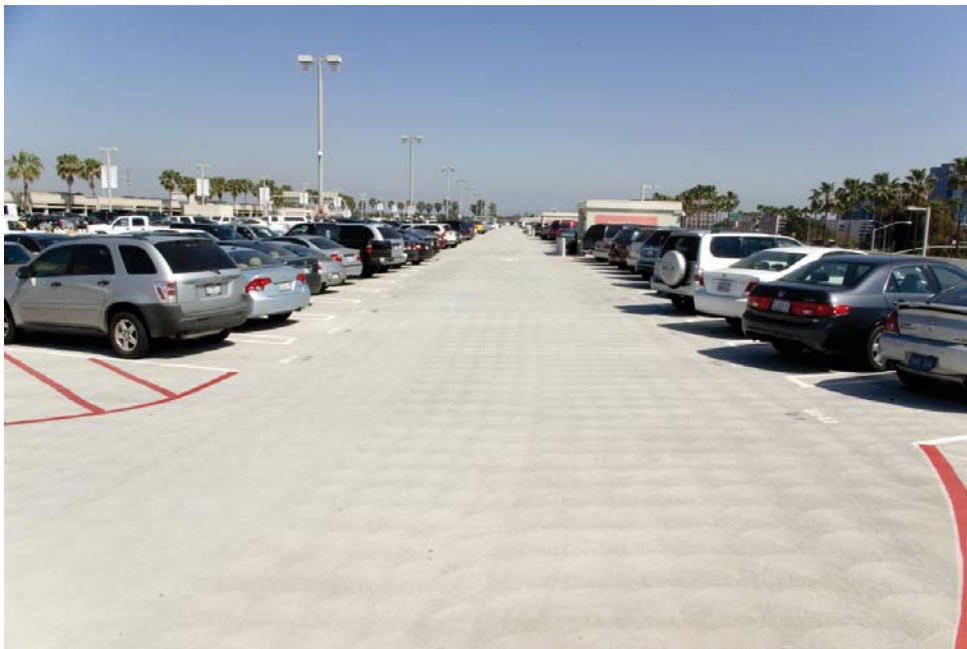
Fig. 12 - The top deck of new parking structure, made with shrinkage compensating concrete, still looks almost new after nine years of heavy use.

Today, nine years after construction, the concrete remains in remarkably good condition. The surfaces of the decks look fresh, the troweled texturing still crisp.
