Long Term Performance of Rapid Strength Concrete (RSC) Slabs on California Highways

Michael I. Darter, PE PhD
Emeritus Professor of Civil & Environmental Engineering,
University of Illinois

5 May 2021

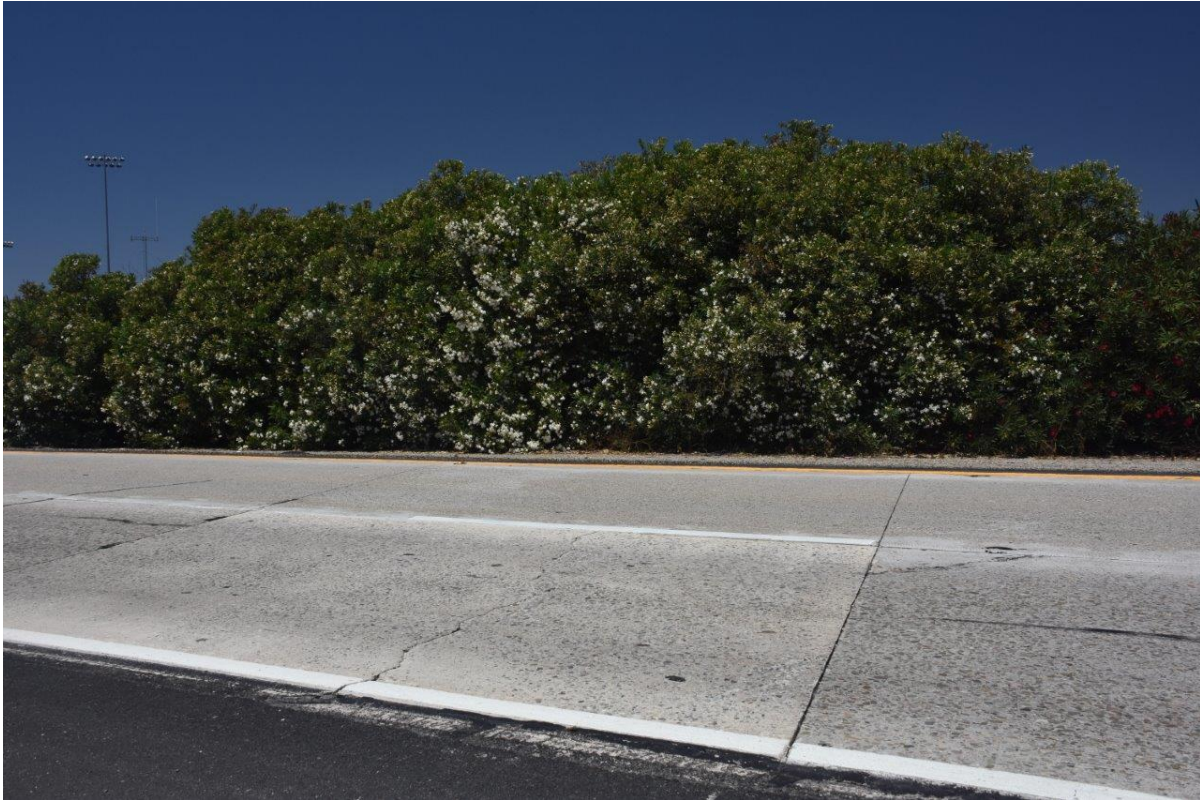
Figure 8. Highway SR-126 near Ventura, CA showing an original 18-19 ft thin slab (conventional concrete) placed in 1972 that developed a transverse fatigue top down crack (this result is common as these thin slabs cannot carry this many heavy truck axle loads).

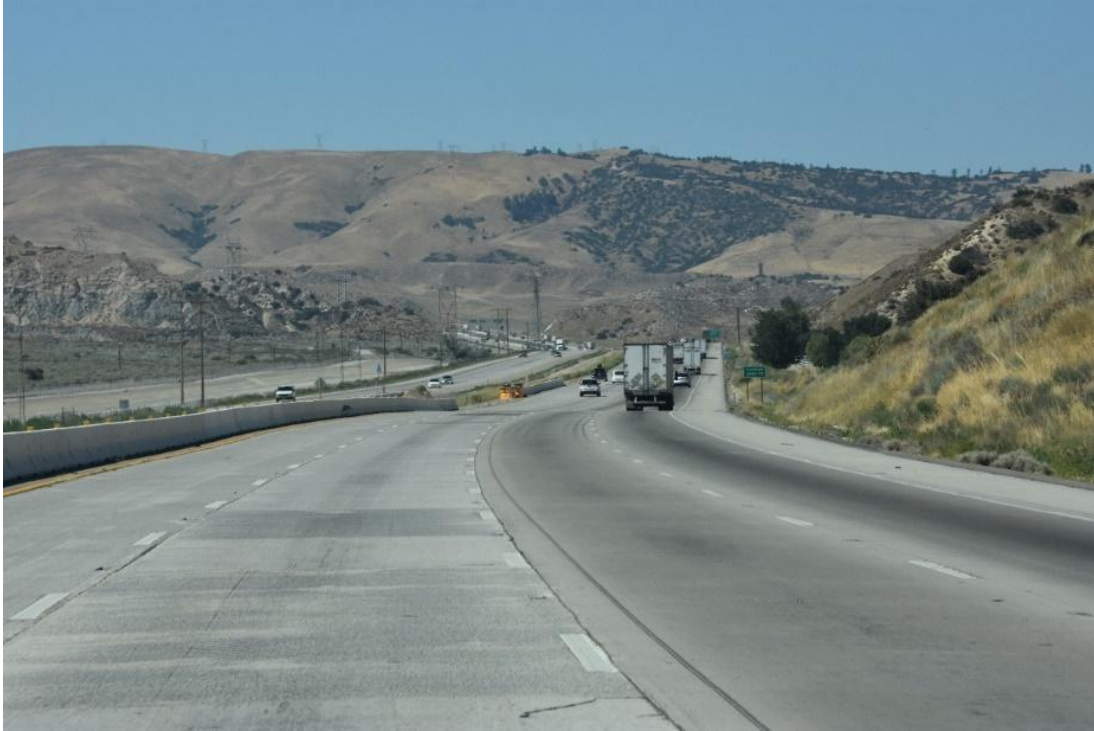
Figure 9. Highway I-5 NB direction (PM 76-88), northwest of Los Angeles showing original inner #1 lane (left) and inner #2 lane with several “Individual RSC” slabs placed in 2005.

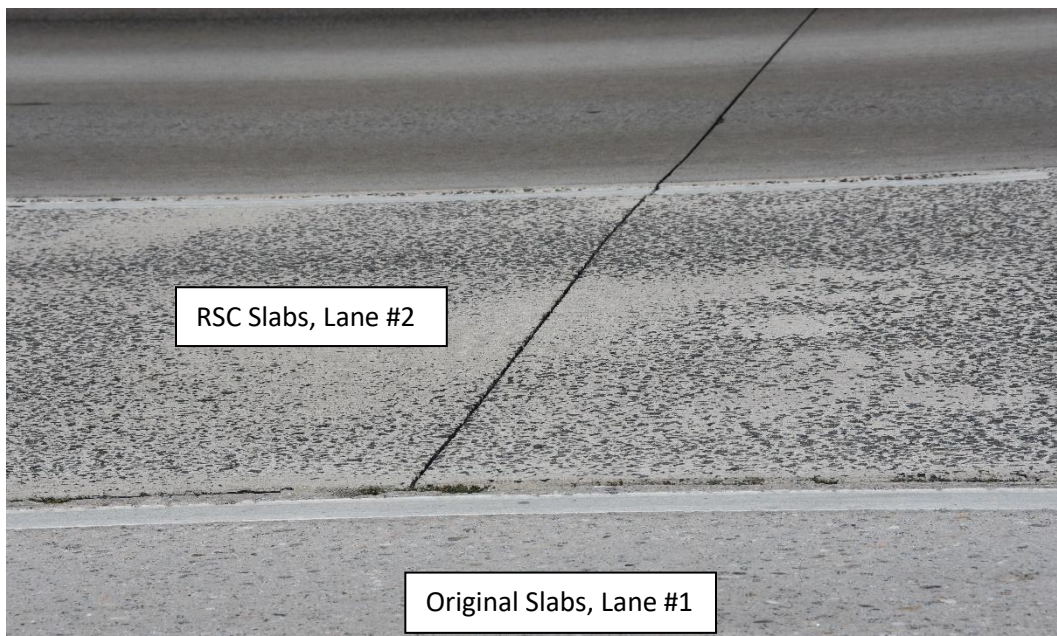
Figure 10. Highway I-5 NB direction (PM 76-88), northwest of Los Angeles showing a transverse joint between two 13-year old RSC slabs (Note that variation in mix color did not create any cracking or disintegration).

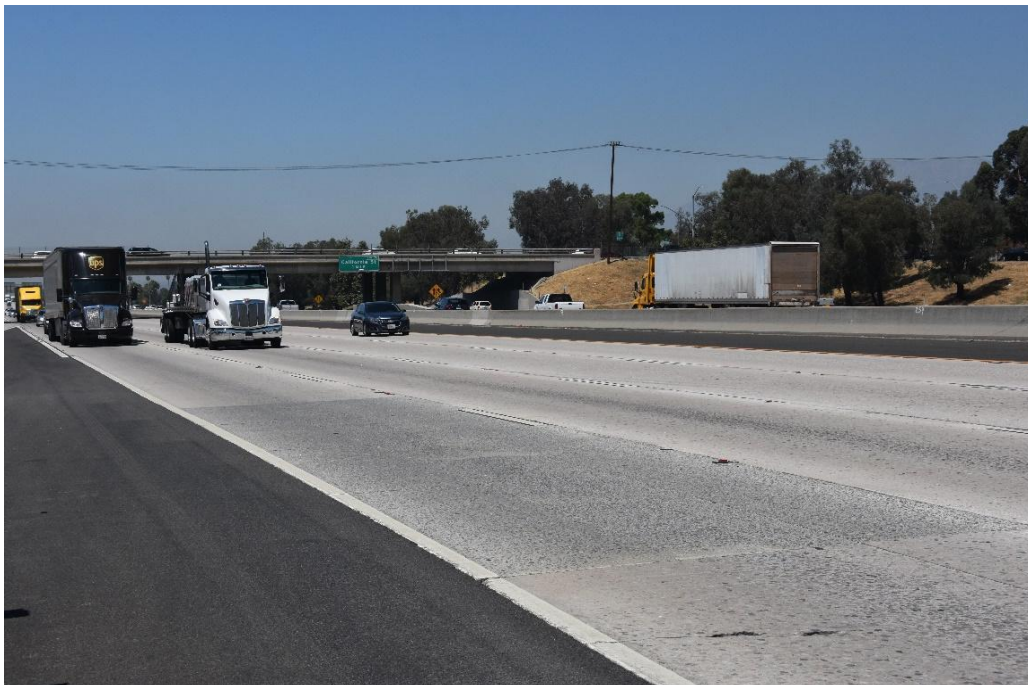
Figure 12. Highway I-10 EB direction (PM 0-39), near San Bernardino showing two 14-year old “Individual RSC” slabs in Lane #4 (outer lane).

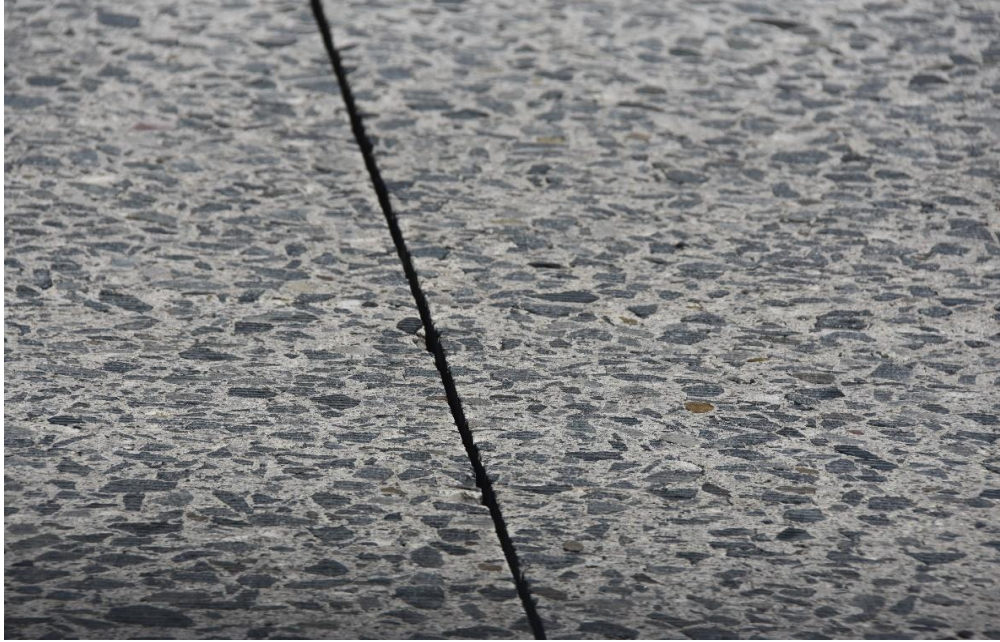
Figure 13. Highway I-10 EB direction (PM 76-88), near San Bernardino showing a closeup of a 14-year old diamond ground transverse joint “Individual RSC” slab in Lane #4 (outer lane). Very good RSC durability shown here existed at all sites.

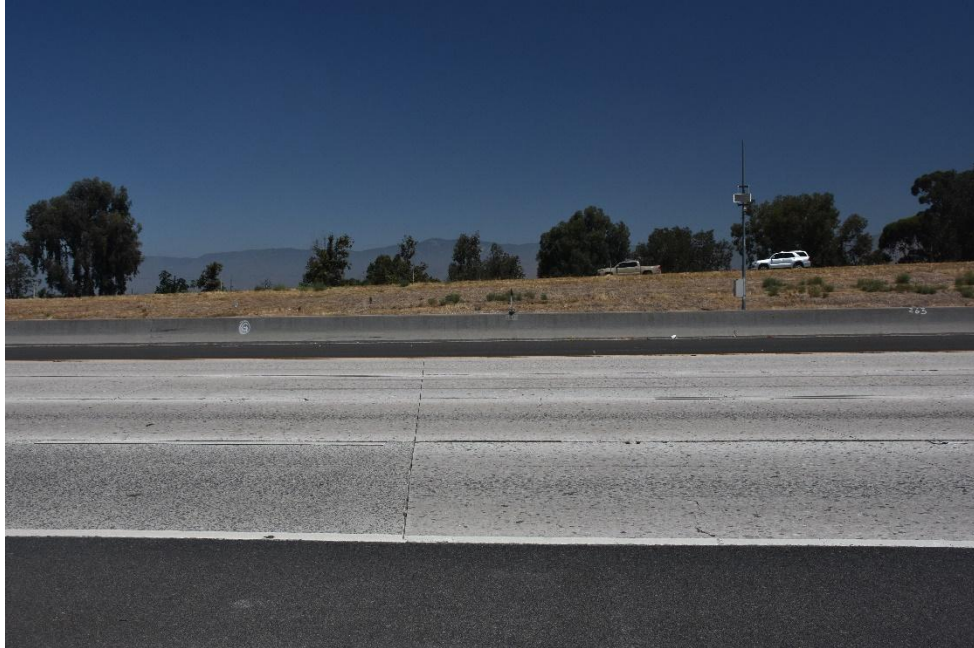
Figure 15. Highway I-10 EB direction (PM 76-88), near San Bernardino showing on the left side a 14-year “Individual RSC” slab surface Lane #4 (outer lane) and on the right an original (1970s) JPCP slab with a transverse fatigue cracking.

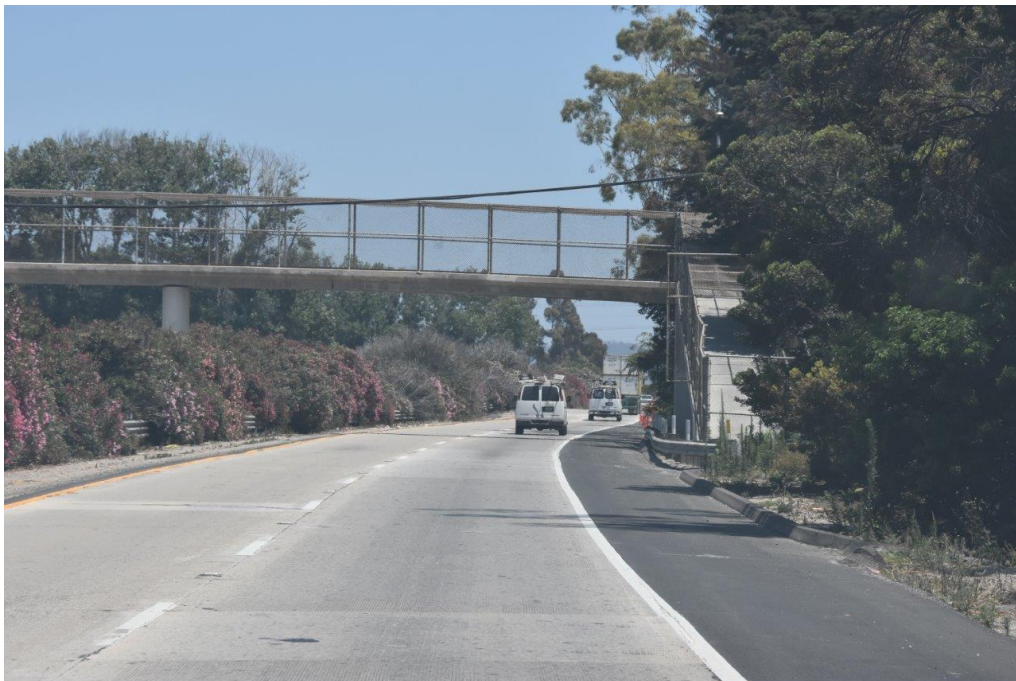
Figure 16. Highway SR 126 (PM 0-13) near Ventura showing some 14-year “Individual RSC” slabs in lanes #1 (left) and #2 (right) that was placed because the original RSC slabs placed in 2005 had transversely fatigued cracked.

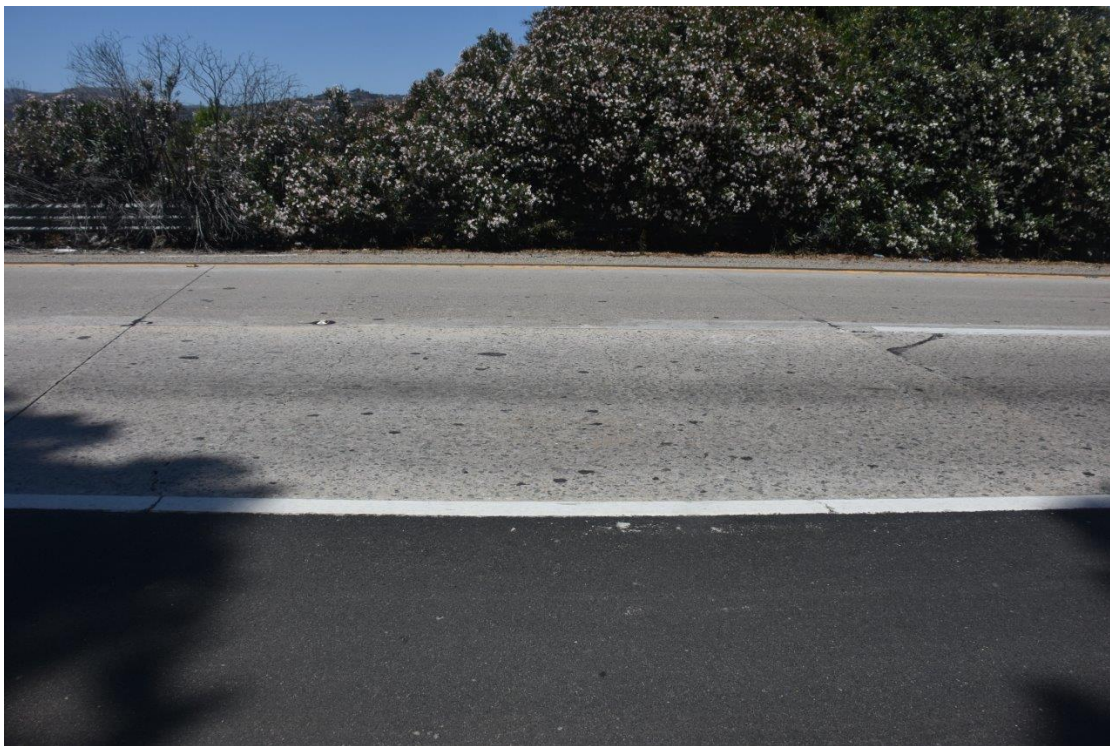
Figure 17. Highway SR 126 (PM 0-13) near Ventura showing a RSC slab placed in outer truck lane in 2006 that has developed a top down transverse fatigue crack.

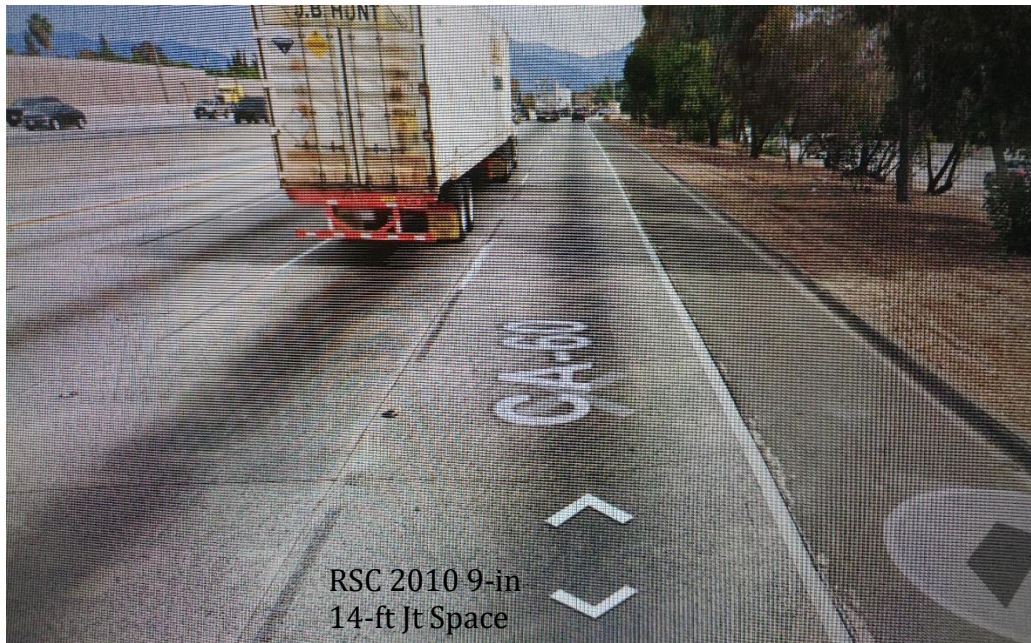
Figure 20. Photo (from Google Maps) of a “Lane Replacement RSC” section on CA-60 located in Los Angeles Co., CA constructed in 2010.

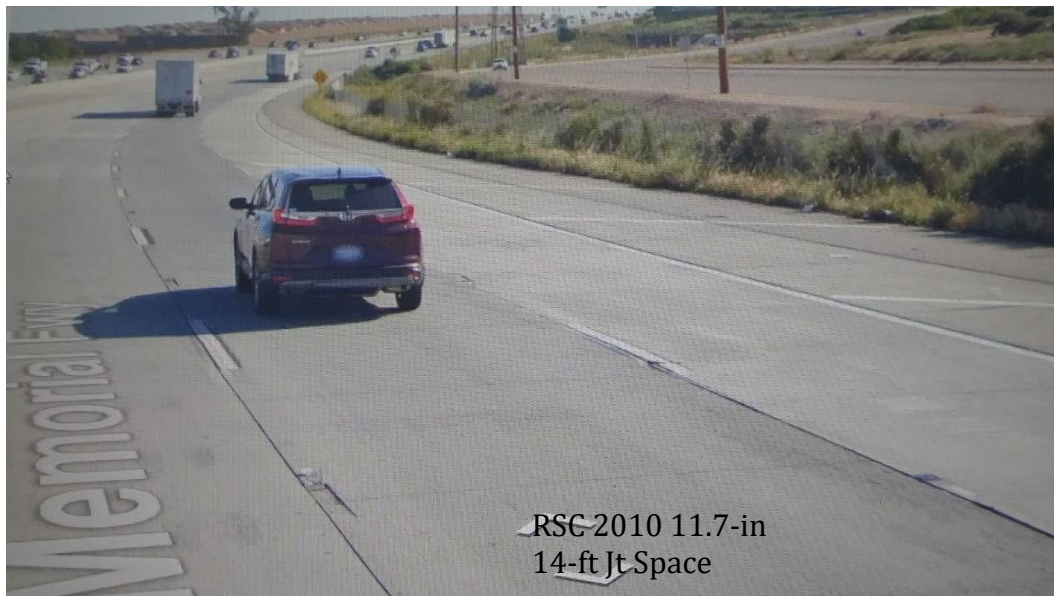
Figure 21. Photo (from Google Maps) of a “Lane Replacement RSC” outer lane section of I-15 located in San Bernardino Co, CA constructed in 2004.

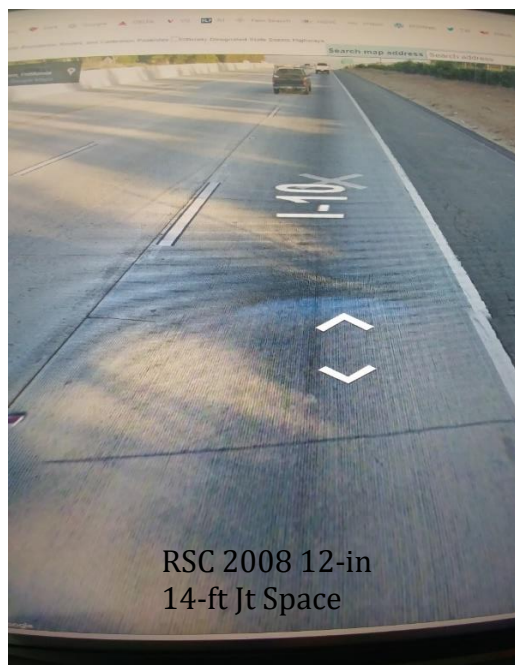
Figure 23. Photo (from Google Maps) of a “Lane Replacement RSC” outer lane section of I-10 located in Riverside Co, CA constructed in 2008.
