## BUYING TIME ON U.S. BRIDGE REPAIRS

New technologies and products can extend pavement life to help address the chronic pavement problems of the highway and bridge building industry.

Equipment World & Better Roads May 2014

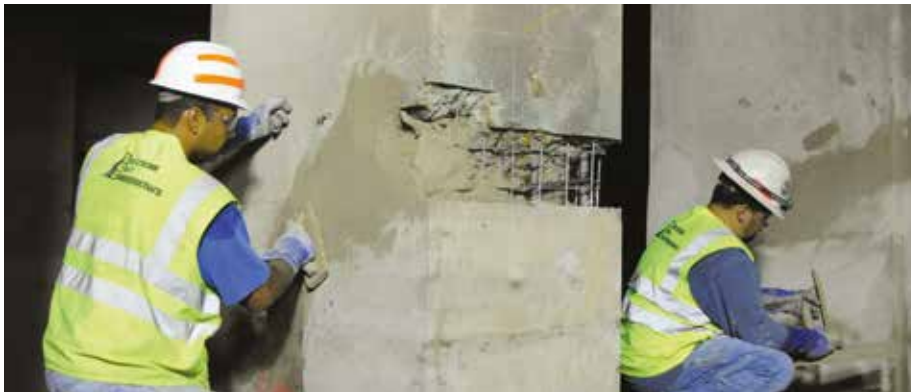
Denver I-70 Bridge Repair

*When rapid-hardening cement combines with water (hydrates), it forms crystalline compounds much faster than does portland cement, getting traffic back on the road in less time.*

In the late 2000s, the I-70 bridge between State Highway 265 and State Highway 2 in Denver was one of 46 bridges in the metro Denver area that was being used past its intended design life. The Colorado Department of Transportation (CDOT) deemed it to be in imminent need of repair, since its 60 expansion joints had been corroded by water and salt and deterioration of the reinforcing steel and surrounding concrete had resulted. With bridge replacement being too costly, CDOT began a repair project to extend the life of the bridge an additional 10 to 15 years. Patching was completed in December 2010, and the whole bridge project was completed in Spring 2011.

Crews removed deteriorated concrete and sandblasted the newly exposed, undamaged surfaces, replacing reinforcing steel and adding galvanized wire mesh for structural reinforcement. This left areas up to 6 inches deep and 8 feet wide to be filled with concrete repair material, and a fast-setting product was needed to complete the work in a short timeframe. Rapid Set® Mortar Mix was selected for the project, as it was able to be applied 6-inches deep in a single application and reached initial set in 15 minutes. Final set was achieved in 35 minutes, with a 2500-psi compressive strength achieved one hour later, allowing crews to move to the next repair section. Rapid Set® Flow Control®, which increases the strength and reduces the shrinkage of the mix when used as a replacement for mixing water, was used to keep the repair material flowable while

still retaining the same strength. Because of its superior speed and workability as well as its resistance to cracking, Rapid Set Mortar Mix was used to repair all of the bridge's horizontal and vertical overhead areas, covering 5,500 square feet of the substructure. Because Rapid Set Mortar Mix was able to be applied in a single application, the project saved an estimated 25 percent in labor costs and completion time.

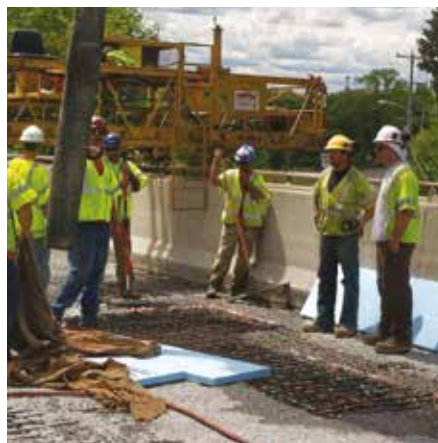
Route 95 Bridge Rehabilitation

*Final set was achieved in 35 minutes, with a 2500-psi compressive strength achieved one hour later, allowing crews to move to the next repair section.*

Because of the high traffic volume on this 50-year-old interstate bridge in Foxboro, Massachusetts, the Massachusetts Department of Transportation (MassDOT) aimed to complete deck repairs throughout the course of two weekends.

Crews milled the existing asphalt concrete and removed deteriorated concrete. Those areas were then filled with a rapid-setting concrete that contained Rapid Set® Low-P® cement and fly ash. Rapid Set Low-P has low permeability and improved resistance to attack from chlorides and de-icing salts, and fly ash was added to eliminate any potential alkali silica reactivity problems. After patching, they placed a concrete overlayment; the 3-1/2 to 4-inch overlayment used the same rapid-setting concrete mix as the patched areas, a first for such a specification in Massachusetts. Concrete was mixed on site in mobile mixers, saving time and eliminating waste. This combination of techniques and materials demonstrated that bridge deck repair can be accomplished in a short period of time.
