REPAIRING CORROSION AT THE MEDALLA LIGHT BEER FACILITY

Medalla Light Brewery, Puerto Rico

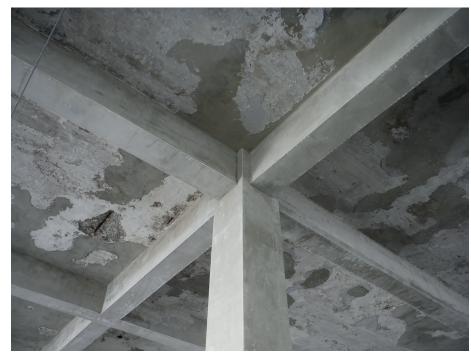
Vertical and overhead repairs after using Rapid Set® products.

AT Specialty Cements brought in CTS V/O Repair Mix and Cement All with Corrosion

Inhibitor to complete the repairs. The V/O Repair Mix was used in all repairs requiring a thickness of 2 inches or more and Cement All was used on the thinner repairs.

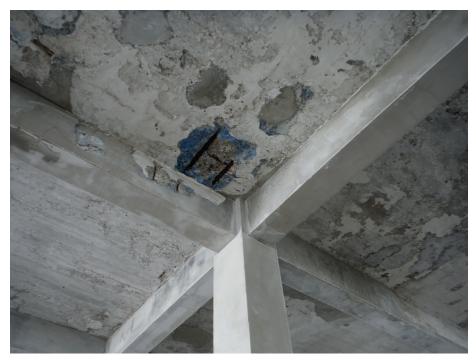
One of only two breweries found in Puerto Rico, the Compañía Cervecera de Puerto Rico is known for its beautiful grounds and facilities, in addition to its well-known beer, Medalla Light. Because it's located in a humid, southern climate, concrete spalling from corrosion of steel reinforcement isn't unusual. Vertical and overhead repairs

were needed on columns, beams, and the ceiling of the quality assurance laboratory to address the problem. The repairs were difficult, with a ceiling height of 30 feet and multiple areas with signs of corrosion.

Vertical and overhead repairs prior to using Rapid $\mathsf{Set}^{\scriptscriptstyle{\circledcirc}}$ products.
