SHRINKAGE-COMPENSATING CONCRETE IN POST-TENSIONED BUILDINGS

A Four-Building Survey – Part One

Structure Magazine April 2010

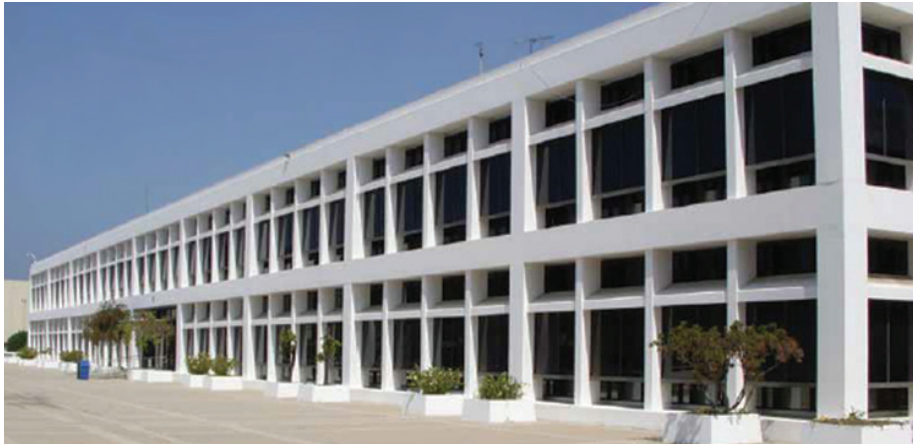
Fig. 1 – South Elevation Building R6 – Looking Down 439-foot Length at Plaza Level. Courtesy of Phillip Yee of Northrop-Grumman.

Each building has three stories, a large first floor plaza level, a second floor, and a roof. The second floors and roofs of the buildings are identical in plan dimension, each 199 feet x 363 feet. The first floors of each building are adjacent, separated by an expansion joint, and orthogonal dimensions are very large: for M5, 422 feet x 243 feet; for R6, 439 x 407 feet. All construction was cast-in-place post-tensioned concrete with unbonded tendons. Column spacing was large, with typical bay sizes of 40 feet x 64 feet. Floor system framing was a one-way slab (shallow pan joists in R6 for extra stiffness) spanning between beams located on and midway between column lines. The intermediate beam was supported by a girder spanning between columns. Seismic framing for both buildings was provided by moment-resistant beam-column frames in both directions.

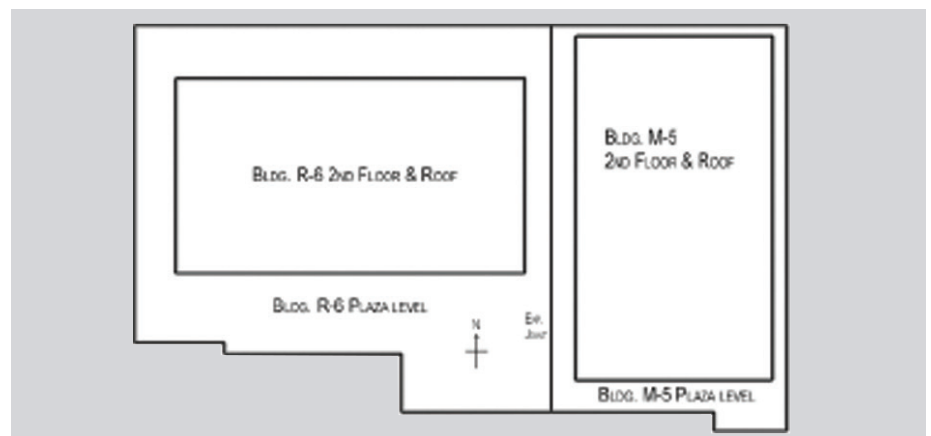
Fig. 2 – Buildings M5 and R6 (plan view). These two buildings required elevated concrete decks with no control joints or pour strips. Shrinkage-compensating concrete was successfully used to cast all floor members. The buildings continue to perform well more than 40 years later. Courtesy of CTS Cement Mfg.

Considering these difficult conditions, a decision was made by the designers to use Type K shrinkage-compensating concrete for all floor members in both buildings.

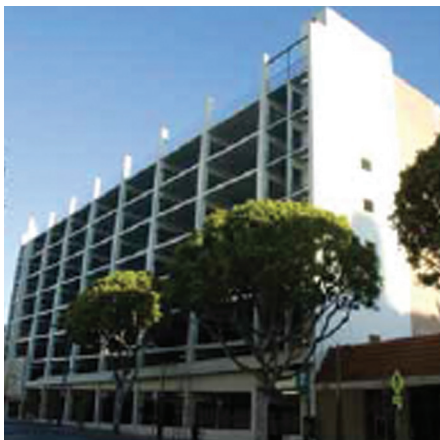
Fig. 3 – Santa Monica Parking Structure #2

Each building was designed for eight elevated levels; four to be built initially, with the capacity for an additional four levels to be added as the need for parking increased. Floors were framed with monolithic cast-in-place post-tensioned lightweight concrete using one-way slabs spanning to clearspan beams (Figure 1). Plan dimensions are approximately 150 feet (three beam spans) by 200 feet (9 slab spans.) One slab construction joint was used, running in the short direction at roughly the third point of the long direction (some of the upper floors used two construction joints). There were no pour strips.

Of particular note is Structure #2, located at 1235 2nd Street. The original four levels (370 cars capacity) were built in 1968, with Type K shrinkage-compensating concrete in the floor systems. Around 1980, an additional four levels were added using conventional portland cement concrete. A series of pins were set into the original deck so that measurements of strain in the slab concrete could be made. These measurements were made at the following points in time:

I inspected the entire floor area of Structure #2 in November, 2009, 41 years after completion of the lower four floors. I carefully observed the areas most susceptible to cracking: the four corners, two with stair/elevator shafts and two without, the ends of the central longitudinal concrete shearwalls, and the areas around the girder framing at each turn-around aisle.

I measured a total of 80 lineal feet of cracks in the lower four floor built with shrinkage-compensating concrete. All of this cracking was on the first elevated slab in the northeast and southwest corners of the building, near the two elevator/stair shafts. The orientation of cracking was consistent with RTS, aggravated not only by the shafts, but by the proximity of a length of basement wall in each location. The largest crack width I measured was 3/32 inch and the longest crack length was about 18 feet. The cracks were visible at the top and bottom of the slab (when both were accessible), and I saw no evidence of efflorescence at the bottom of any crack,

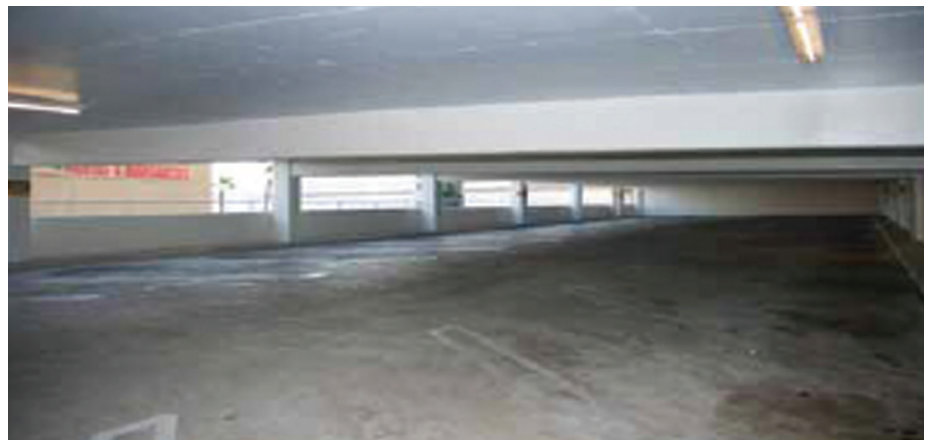
Fig. 4 – Beam and Slab Framing (4th Level)

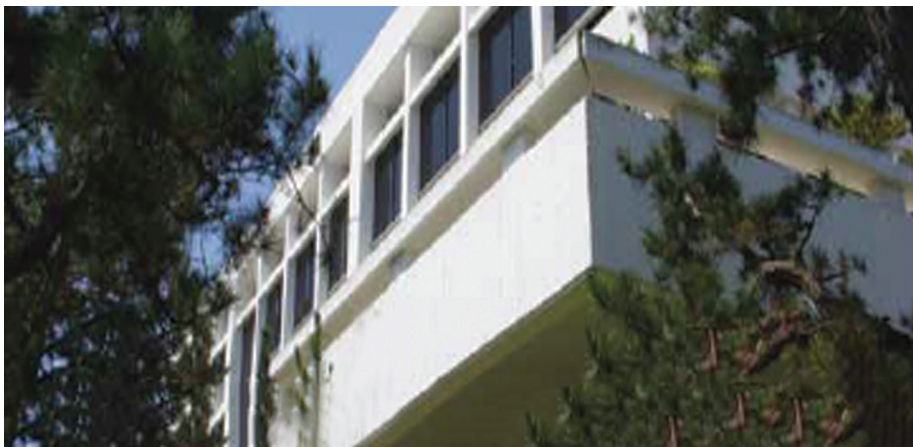
Fig. 5 – Building M5, southeast corner showing dramatic cantilevered post-tensioned beams at Plaza Level. Courtesy of Phillip Yee of Northrop-Grumman.

in the presence of Northrop-Grumman facilities personnel. The structural condition of the observable portions of the floor system and columns was excellent, virtually crack-free after four decades of continuous service. Northrop-Grumman facilities personnel (Jimmy Guerrero, P.E., Facilities Project Manager, and Phillip Yee, Facilities Risk Manager), who have worked onsite at this facility for years, report that the structural performance of the buildings has been excellent and they have required no unusual maintenance or repairs over their entire service lives.
