# TEODORO MOSCOSO BRIDGE REHAB

With minimal traffic disruption

Teodoro Moscoso Bridge, San Juan, Puerto Rico, repairs of side barriers and drain basins, partial-depth concrete pavement repairs using Rapid Set® Cement All®, Mortar Mix, V/O Repair Mix, WunderFixx®, CR Concrete Resurfacer, DOT Repair Mix, and Corrosion Inhibitor.

Roads & Bridges Magazine June 2017

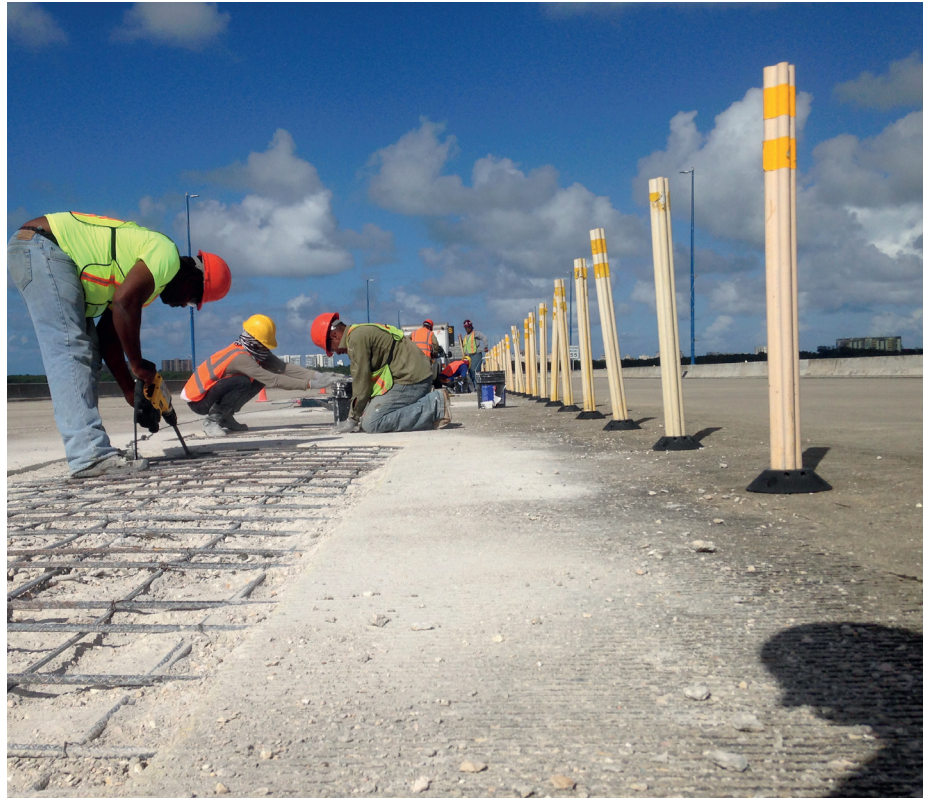
Phase 1A

During the first stage of the rehab program, a soundness test was performed in areas of the pavement near the toll plaza, where corrosion deterioration and concrete delamination were evident. The 10-person maintenance crew found that the top rebar didn't have enough concrete cover, thus was attacked by the high concentration of chlorides in the environment. This, in turn, caused deep cracks and fragmentation in the concrete.

AT Specialty Cements recommended partial-depth repair, which consists of removing the top one-third of damaged slab and replacing it with appropriate repair materials. Although the method is faster and less costly than having to replace a slab down to the base, the bridge's operation manager, Ing. Juan Matos Ostolaza, still had concerns about the downtime needed to repair these sections in close proximity to the high-traffic toll booth.

To minimize road closure time, Matos Ostolaza and the bridge design department needed a very fast structural mortar with early high strength to perform the partial-depth repairs. After months of product evaluations, they selected CTS Cement's Rapid Set® DOT Repair Mix, as it is a durable solution for time-critical jobs in harsh environments.

They also added Rapid Set® Corrosion Inhibitor to the DOT Repair Mix, which creates a protective barrier on embedded steel that repels water and reduces chloride ion permeability. As part of the Rapid Set family of products, the powder additive can be combined with any Rapid Set repair product during the mixing process to protect against corrosion.

The fast-acting products enabled the crew to open all lanes to traffic three hours after repairs were made, which meant minimal interruption to the operation of the toll plaza.

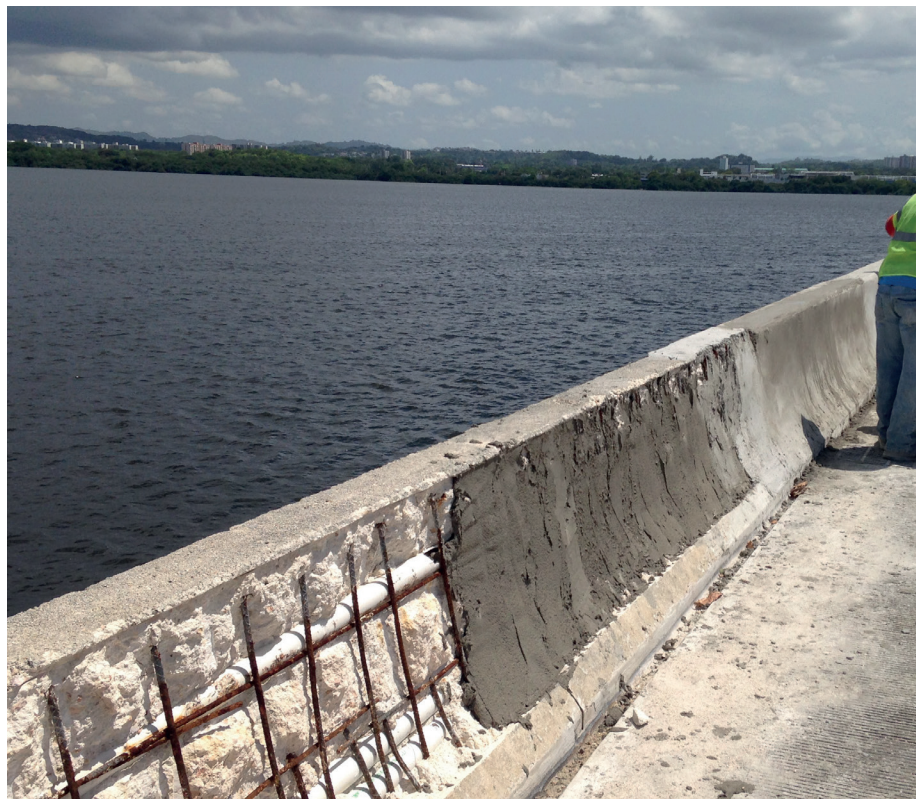
Phase 2A

The lateral barriers of the bridge were at least 26 years old with concrete delamination spalling that was quite evident in numerous areas. An extensive field study found that almost 45 percent of the barriers' vertical surface had some degree of concrete deterioration due to corrosion. As with the pavement near the toll plaza, the corrosion was caused by lack of sufficient concrete coverage of the reinforced bars.

All damaged areas were scattered spots— isolated areas approximately 5x5 feet and 8x8 feet in size—so the bridge needed a durable yet aesthetic solution that would blend well with existing concrete. To do this, AT Specialty Cements recommended Rapid Set® V/O Repair Mix for all vertical partial-depth repairs. The mix is tinted gray to match most portland concrete surfaces. It also bonds well with existing concrete and is resistant to both freeze/thaw and corrosion. Rapid Set® Corrosion Inhibitor was also added to the mix.

The crew finished the barrier surfaces with a thin layer of Rapid Set® WunderFixx®, a high-performance patching product, to provide a smooth surface ready to receive the anti-carbonation protection coat.

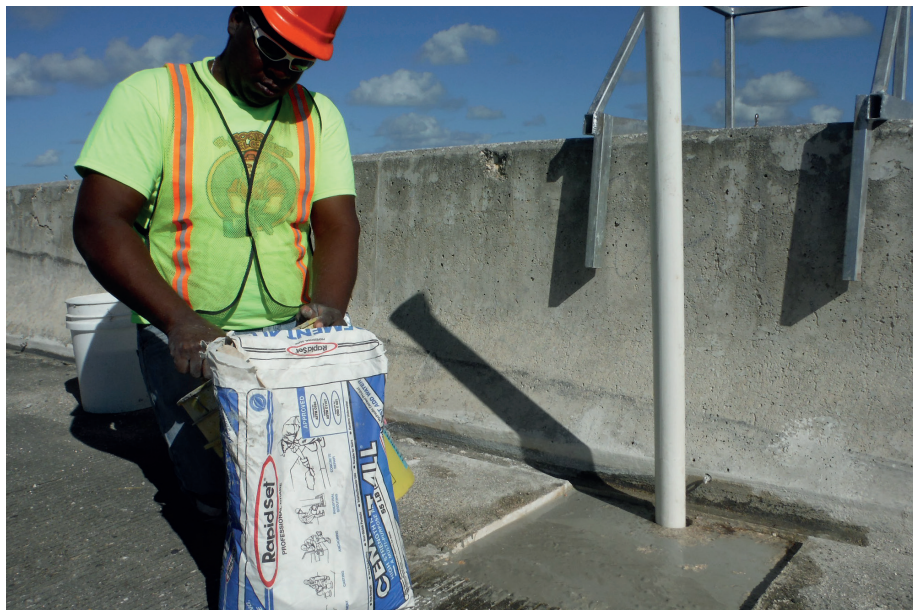
Phase 3

During the final phase of the project, a new system of floor drains was needed on the east side of the bridge to allow all surface water to discharge.

For the new drain pipe installation, the crew core-drilled the new drains and saw-cut and chipped out the drain ditch with a jackhammer. The new pipes were anchored and fixed with Rapid Set® Cement All®, a fast-setting, high-

strength, non-shrink grout. The multipurpose product is durable in wet environments and typically sets in 15 minutes and is ready for traffic in one hour. Again, the crew added Rapid Set® Corrosion Inhibitor to the mix. The drain ditch was finished with Rapid Set® CR Concrete Resurfacer. Typically used to resurface damaged or discolored concrete, the resurfacer is formulated with cutting-edge self-curing technology, so it does not need to be wet-cured in most applications.

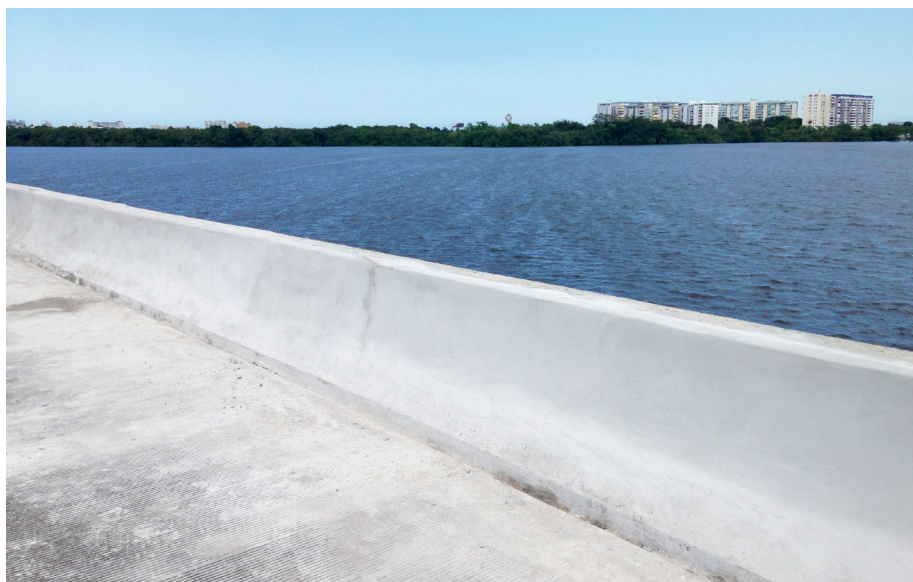
Finished result
