# 1,200-FOOT POST-TENSIONED SLAB WITH TYPE K CEMENT CLEARED FOR TAKE-OFF

19 Years after placement of three demonstration pavements, the post-tensioned design shows best performance

PTI Journal December 2006

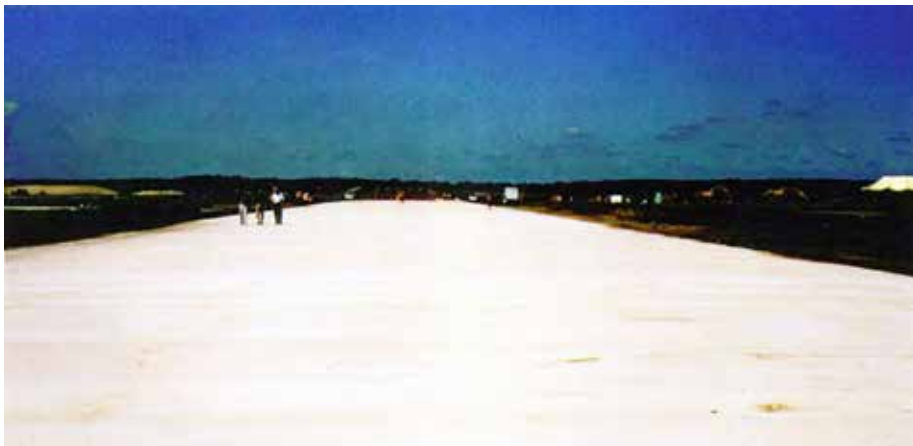
Fig. 1 – The finished 1200 foot slab shortly after pouring, probably the longest unjointed concrete pavement in North America.

The second innovative pavement slab (IP2) was 1,200 ft. long and used the same fibrous concrete with Type K cement but was post-tensioned longitudinally. This combination of technologies had never been done before on a pavement. The research objective was to build the slab without saw-cut shrinkage control joints; pre-stressing would compress the concrete to prevent shrinkage cracking. Longitudinal pre-stressing came from 1,200 ft. long post-tensioning tendons placed twelve inches apart. There was no transverse post-tensioning because the designers relied on the interaction of the steel fibers and shrinkage compensating concrete to provide pre-stressing across the slab. A double layer of polyethylene film was laid over the base course to act as a slip-sheet to reduce subgrade drag. Barenberg calculated the increase in flexural strength added by post-tensioning, and suggested a pavement thickness of just seven inches.

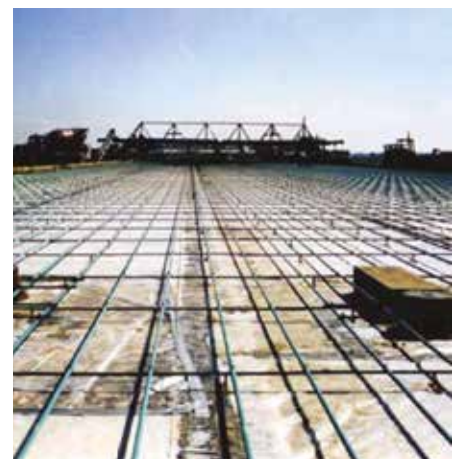
Fig. 2 – 1200-ft-long post-tensioning tendons ready for concrete from the bridge deck paver in the distance

Post tensioning was applied in two phases. An initial load of 30 kips was applied when the concrete had reached 2000 psi compressive strength, the morning after placement was completed. The final stressing to 46.9 kips was applied when the concrete reached 3500 psi, one day later. The tensioning was done in a special sequence, innermost tendons first, outermost next, and then the intervening ones, to avoid torquing the slab.

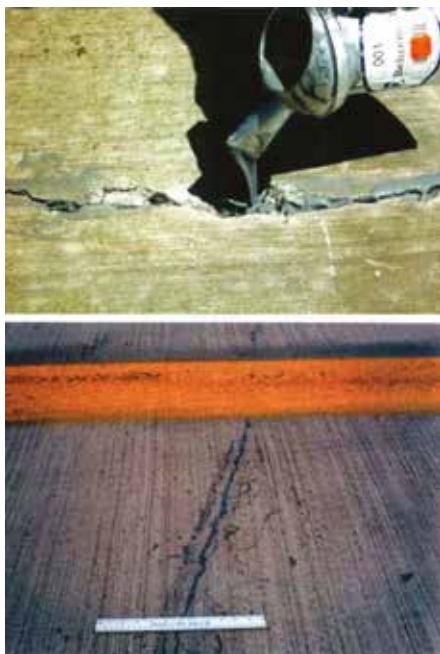
Fig. 3 – The transverse crack in the unjoined slab, repaired with epoxy, has remained closed ever since post-tensioning.

wide transverse crack was found in the middle of the second day's pour. As the day heated up, the crack began to close. When it was 1/8 inch wide, it was sealed with 5 gallons of epoxy and the stressing of the post-tensioning tendons was begun, effectively clamping the crack shut.

It is believed that the crack was caused by a severe temperature drop in the concrete. Thermal monitoring devices, installed in the concrete as part of the demonstration project, recorded internal temperatures as high as 135°F shortly after the concrete was placed. The next morning, however, the internal temperature was 90°F, a 45° drop.

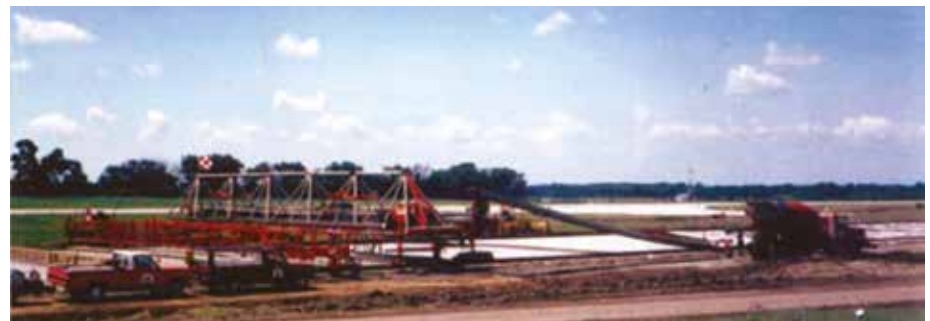
Fig. 4 – The bridge deck paver, an 80-foot truss with conveyor belts, and a truck feeding it concrete.

Their idea was to construct a long, long slab with no joints at all. Pavements are usually placed in strips about 25 feet wide, with longitudinal joints between the strips. Raterree and Barenberg wanted to use bridge deck paving equipment that could cover the entire width of a taxiway; 75 feet in one pass. According to Stan Herrin, Manager of CMT's Springfield Aviation Group who worked on both the Atlantic City and Rockford projects, the thinking process ran, "We could pave 75 feet wide and use shrinkage-compensating concrete and fibers to provide the transverse pre-stressing that's required. Longitudinally, the Type K cement would allow us to pave for up to a week without having to put the post-tensioning on."

The Rockford Demonstration Project included three contiguous sections of taxiway paralleling a new runway extension. Each section would be placed in one 75 ft. wide pass using a Rotec bridge deck paver, and each would have identical subgrades.

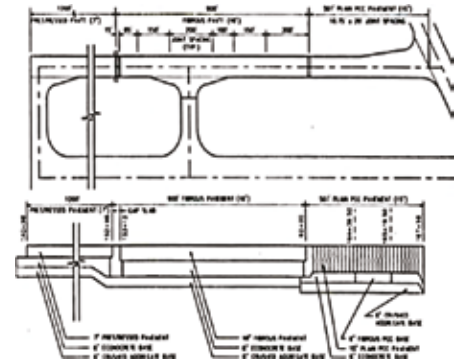
Fig. 5 – Layout of the taxiway, and elevations showing the differing thickness of the pavements.

The "control" section was a conventional pavement 560 ft. long, designed in accordance with FAA Advisory Circular No. 150/5820-6C: concrete with Type I portland cement, 15 inches thick, with 18.75 ft. longitudinal joint spacing and 20 ft. transverse joint spacing. Shrinkage control joints would be saw-cut after placement.

The first innovative pavement slab (IP1) was 900 ft. long, paved with shrinkage compensating concrete made with Type K cement and containing 85 lbs. of steel fibers per cubic yard. The steel fibers added flexural strength, and the engineers calculated they could reduce pavement thickness to ten inches. The objective was to test how far apart the natural cracking of the material would be by increasing the spacing of the joints and seeing if it cracked in between them. Transverse joints would be saw-cut at 85 ft., 100 ft., 150 ft. and 200 ft. There were no longitudinal joints.

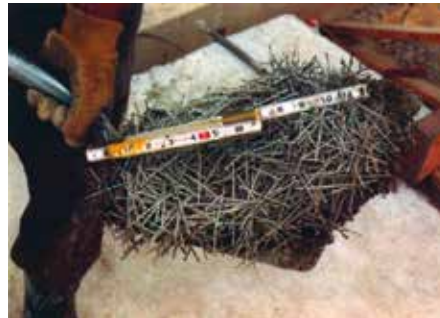
Fig. 7 – Steel fibers 2.5 in. long created tensile forces to hold the slab in compression as Type K cement expanded.

Type K cement, developed in the 1960s, is a combination of 85% conventional portland cement and 15% expansive hydraulic cement. Concrete made with Type K experiences controlled expansion during the first 7 days of curing, the period when shrinkage-stress most often occurs. If the expansive concrete is internally restrained, (by steel reinforcing bars or reinforcing fibers, for instance) the concrete stretches the steel as it grows. Like a rubber band holding together a deck of cards, this puts compression on the concrete, resisting the stresses that cause cracks.

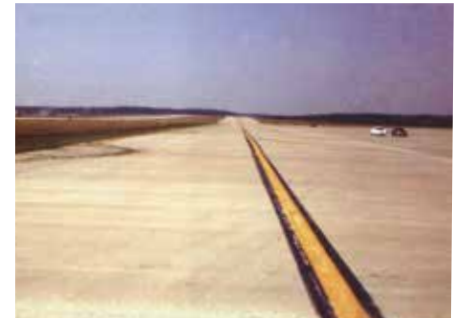
Fig. 8 – After 10 years of use, the airport administration reports that the post-tensioned slab has needed only minimal maintenance.

post-tensioned slab. "After a decade, it is still nearly pristine," he marvels.

Franz Olson, Deputy Director of Operations & Facilities of Chicago-Rockford International Airport, is also pleased with the joint-less taxiway. "The pavement has held up extremely well. The cracking has been very, very minimal. There were some initial concerns with the fibers breaking loose, but that has not occurred. It has not caused any Foreign Object Damage (FOD) concern.

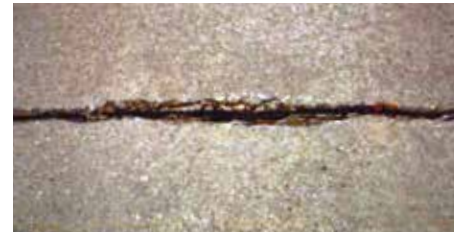
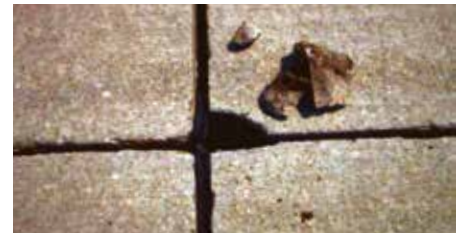
Fig. 9 – Joints in the non-post-tensioned pavement show the spalling typical of 10 years of heavy aircraft traffic and snowplow damage.

In 2003, ten years after the taxiway was completed, an inspection team surveyed the pavements and evaluated them using the Pavement Condition Index (PCI). PCI, developed by the US Army Corps of Engineers and adopted by the FAA, provides a numerical value between 0 and 100 defines the condition of a pavement, 100 representing an excellent pavement. The control section of the pavement had spalling on almost all its transverse joints. It was rated in Good condition, with a Pavement Condition Index (PCI) of 67.

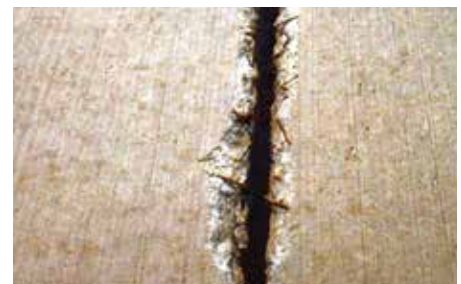
Fig. 10 – The fibrous slab also suffered spalling at its sawcut joints..

The IP1 slab also developed transverse cracks in the first year, some of which have gone the full width of the pavement. The overall crack pattern suggests that the natural crack-spacing for this type of concrete is about 40 ft., roughly double that of control section.

The non post-tensioned slab (IP1) was rated Very Good. While there's no standard procedure for a PCI of long jointed fibrous pavement, it was estimated at a PCI of 82. Transverse cracks show some spalling, probably from snowplow damage. There are longitudinal cracks in approximately 40% of the slab, but they are straight, tight and show little spalling. The post-tensioned slab (IP2) was rated in excellent condition. Again, there is no standard procedure for a PCI of this kind of pavement, but it was estimated at over 98, a nearly perfect score.

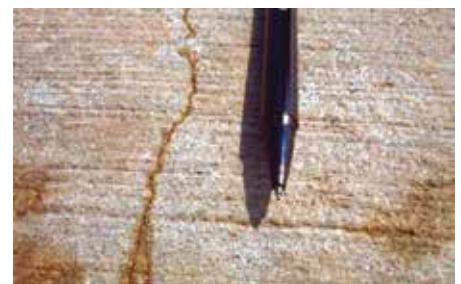
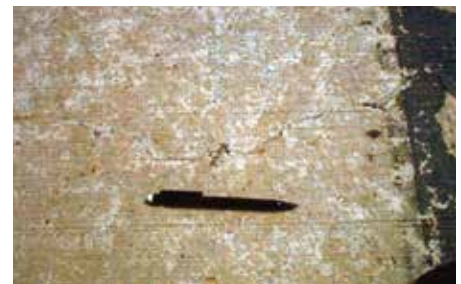
Fig. 11 – The post-tensioned pavement has cracks, but they are tight and less vulnerable to impacts that cause spalls.

Other transverse cracks have appeared, but they are hairline cracks and not the full width of the pavement. A report by the American Society of Civil Engineers described them as, "difficult to find at normal walking speeds." Only one new transverse crack appeared between the end of 5-year monitoring and the 10-year survey. The longitudinal cracks are tight, typically 2-16 ft. long, and show little spalling.
