PROJECT BRIEF

STUCCO REPAIRS MADE WITH NO DISRUPTION TO RESIDENTS

Stucco repair

Walnut Creek, CA

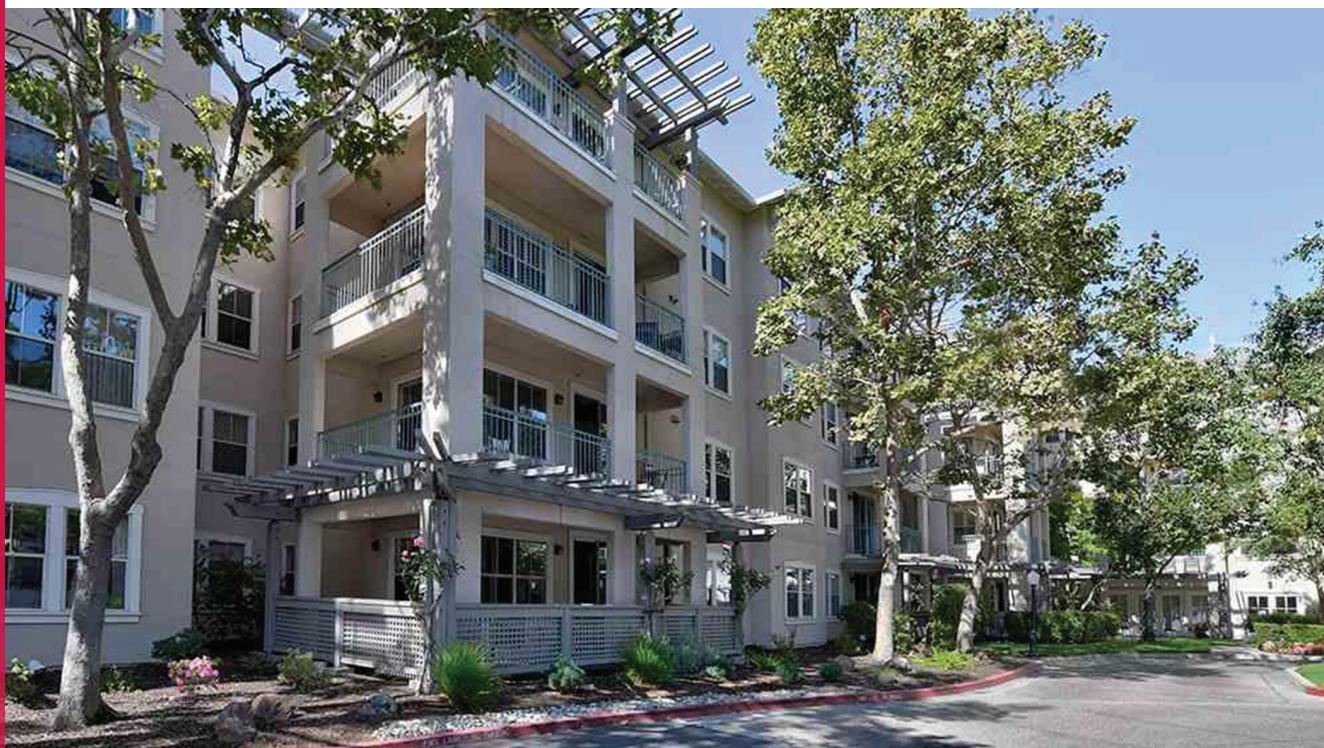
When the active senior adult condominiums of Rossmoor needed stucco repairs, Stucco Patch proved to be the ideal solution. Woodpeckers had drilled holes and built nests throughout the condominium community, and Pacific Trim Painting was hired to remove all exterior architectural pop outs and recoat the stucco.

Due to the buildings' height, some up to six stories tall, workers had to erect scaffolding. Once the pop outs were removed, excess material was ground off and workers used a ½-inch drill and paddle to mix a total of 300 bags of Stucco Patch. Workers placed the self-curing Stucco Patch, floated it out and finished it with a sponge float and deck brush. Texturing techniques were used to blend the repair areas with the existing building.

Because the Stucco Patch sand was similar to the existing sand on buildings, repairs were accomplished with a single coat and labor costs were saved. Buildings were able to be patched, primed and repainted the same day. Work progressed during the dry season in 70- to 80-degree temperatures and without interfering with the residents' daily living.
