## BRIDGE REHAB WITH MINIMAL TRAFFIC DISRUPTION

Teodoro Moscoso Bridge, San Juan, Puerto Rico

### FAST-SETTING CEMENT USED TO REHAB THE TEODORO MOSCOSO BRIDGE

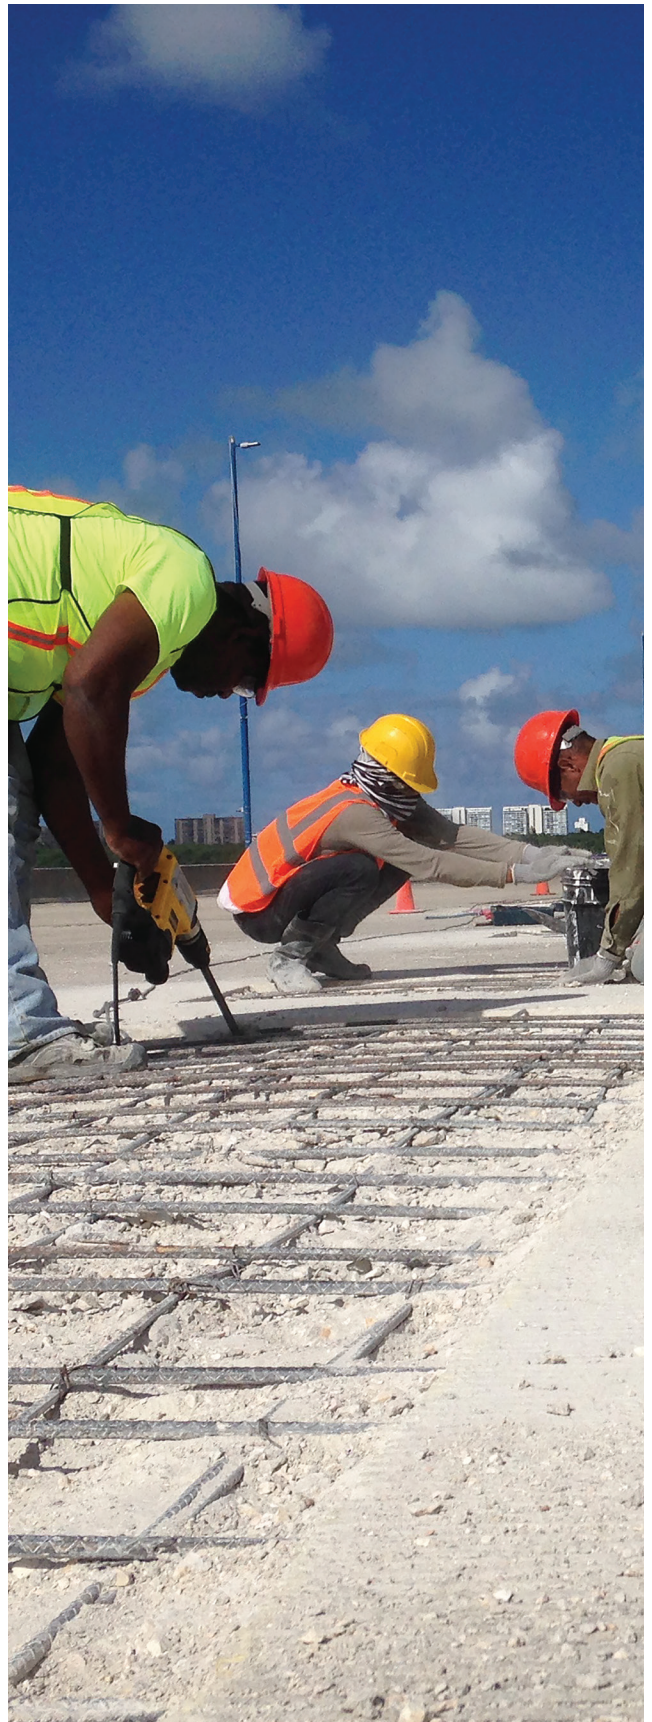
During the first stage of the rehab program, a soundness test was performed in areas of the pavement near the toll plaza, where corrosion deterioration and concrete delamination were evident. The 10-person maintenance crew found that the top rebar didn't have enough concrete cover, thus was attacked by the high concentration of chlorides in the environment. This, in turn, caused deep cracks and fragmentation in the concrete.

AT Specialty Cements recommended partial-depth repair, which consists of removing the top one-third of damaged slab and replacing it with appropriate repair materials. Although the method is faster and less costly than having to replace a slab down to the base, the bridge's operation manager, Ing. Juan Matos Ostolaza, still had concerns about the downtime needed to repair these sections in close proximity to the high-traffic toll booth.

To minimize road closure time, Matos Ostolaza and the bridge design department needed a very fast structural mortar with early high strength to perform the partial-depth repairs. After months of product evaluations, they selected CTS Cement's Rapid Set DOT Repair Mix, as it is a durable solution for time-critical jobs in harsh environments.

They also added Rapid Set Corrosion Inhibitor to the DOT Mix, which creates a protective barrier on embedded steel that repels water and reduces chloride ion permeability. As part of the Rapid Set family of products, the powder additive can be combined with any Rapid Set repair product during the mixing process to protect against corrosion.

The fast-acting products enabled the crew to open all lanes to traffic three hours after repairs were made, which meant minimal interruption to the operation of the toll plaza.

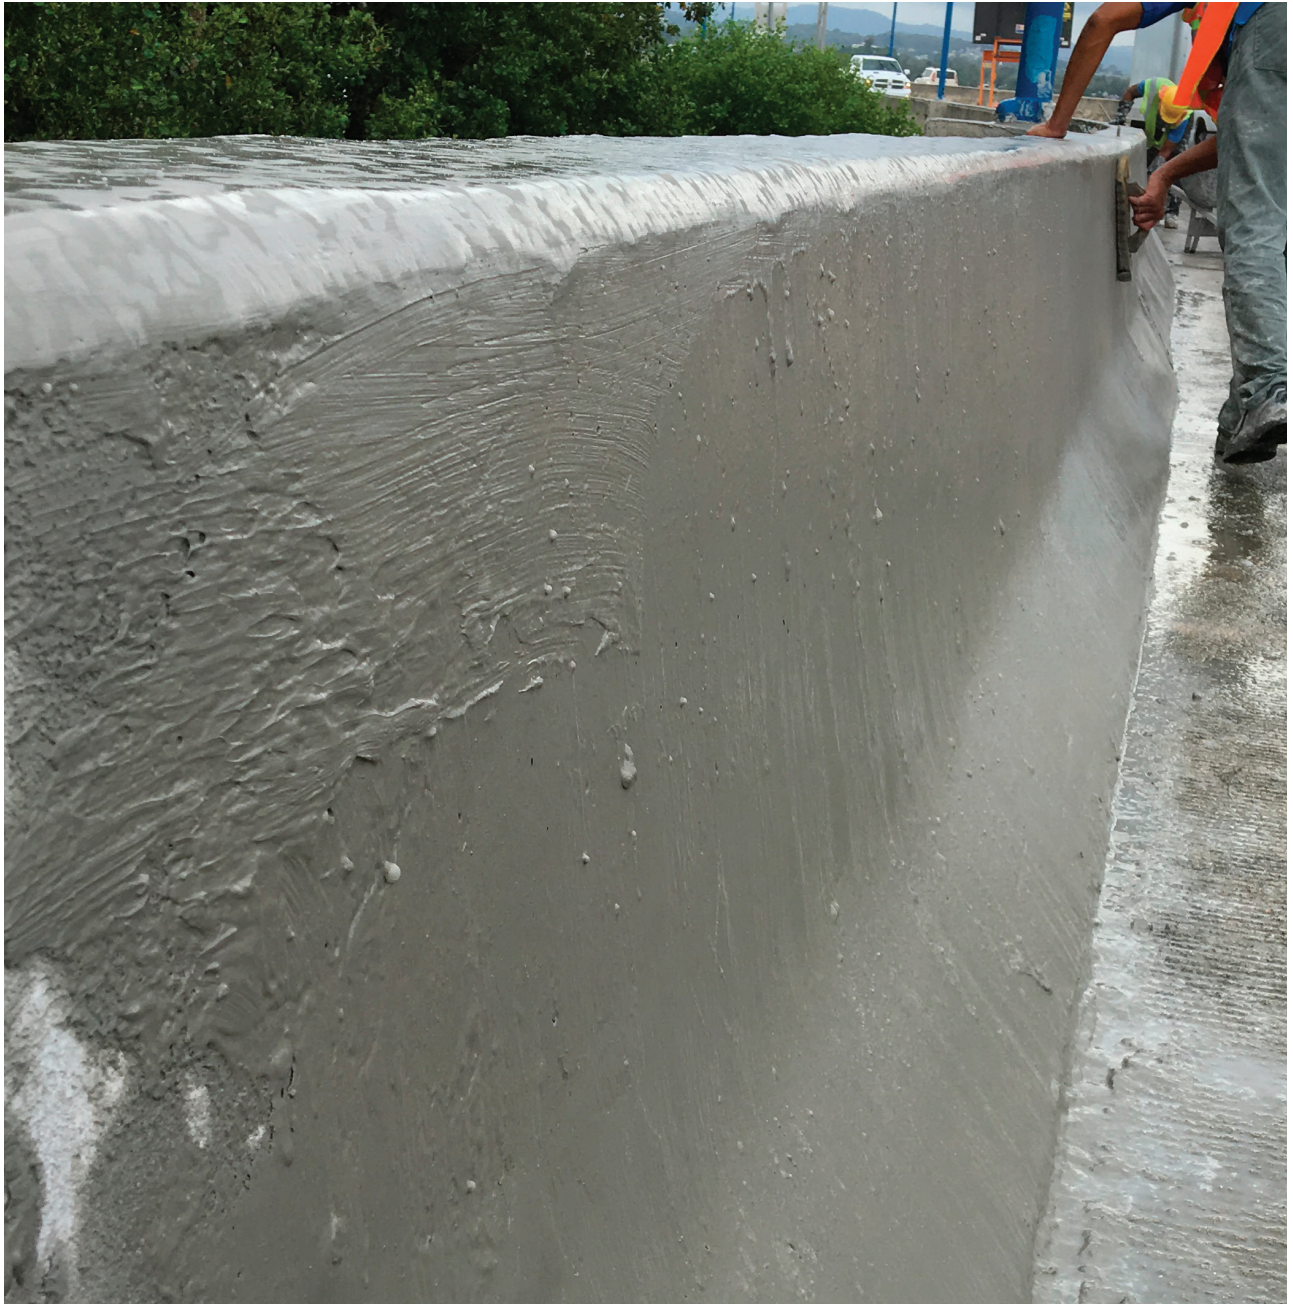
The lateral barriers of the bridge were at least 26 years old with concrete delamination spalling that was quite evident in numerous areas. An extensive field study found that almost 45 percent of the barriers' vertical surface had some degree of concrete deterioration due to corrosion. As with the pavement near the toll plaza, the corrosion was caused by lack of sufficient concrete coverage of the reinforced bars.

All damaged areas were scattered spots—isolated areas approximately 5x5 feet and 8x8 feet in size—so the bridge needed a durable yet aesthetic solution that would blend well with existing concrete. To do this, AT Specialty Cements recommended V/O Repair Mix for all vertical partial-depth repairs. The mix is tinted gray to match most portland concrete surfaces. It also bonds well with existing concrete and is resistant to both freeze/thaw and corrosion. Corrosion Inhibitor also was added to the mix.

The crew finished the barrier surfaces with a thin layer of WunderFixx®, a high-performance patching product, to provide a smooth surface ready to receive the anti-carbonation protection coat.
