National University College, Arecibo Campus Parking Structure

Structural Repairs on the Arecibo Campus Completed Months Ahead of Schedule

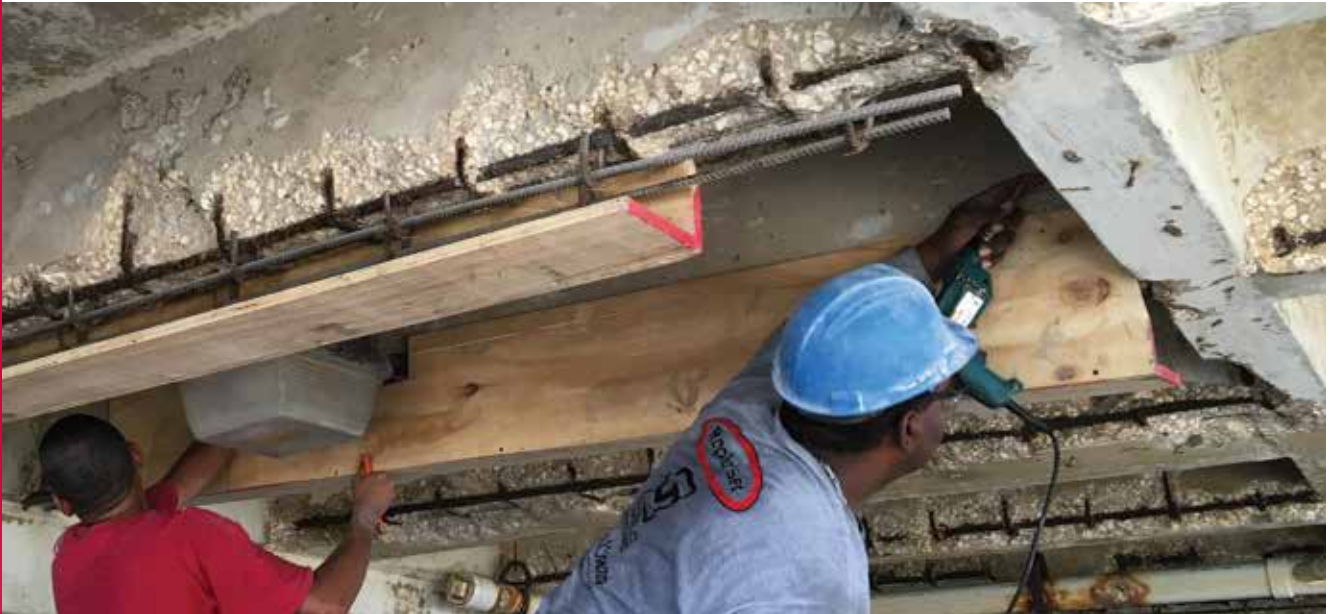
A structural engineer inspected and found more damage than expected on the parking structure's beams and columns. This was due, in part, to insufficient concrete coverage on the beams' bottom reinforcement bars. The solution was to use both partial-depth and full-depth concrete repair methods with rebar replacement. Because the Rapid Set products can be applied at thicknesses up to six inches, the repair crew was

The contractor used CTS Cement's Rapid Set® family of products to provide quality repairs in a short time frame. In particular, V/O Repair Mix® was chosen because it contains a corrosion inhibitor and fibers. Other products used include Mortar Mix®, Cement All® grout, and WunderFixx® concrete patching compound. These fast-setting materials also allowed the contractor to perform the bulk of repairs before daily high-wind conditions set in.
