BRIDGE HINGE RECONSTRUCTION

Structure Magazine January 2015

Accelerated Bridge Construction for Long Lasting Repairs on Aging Highways

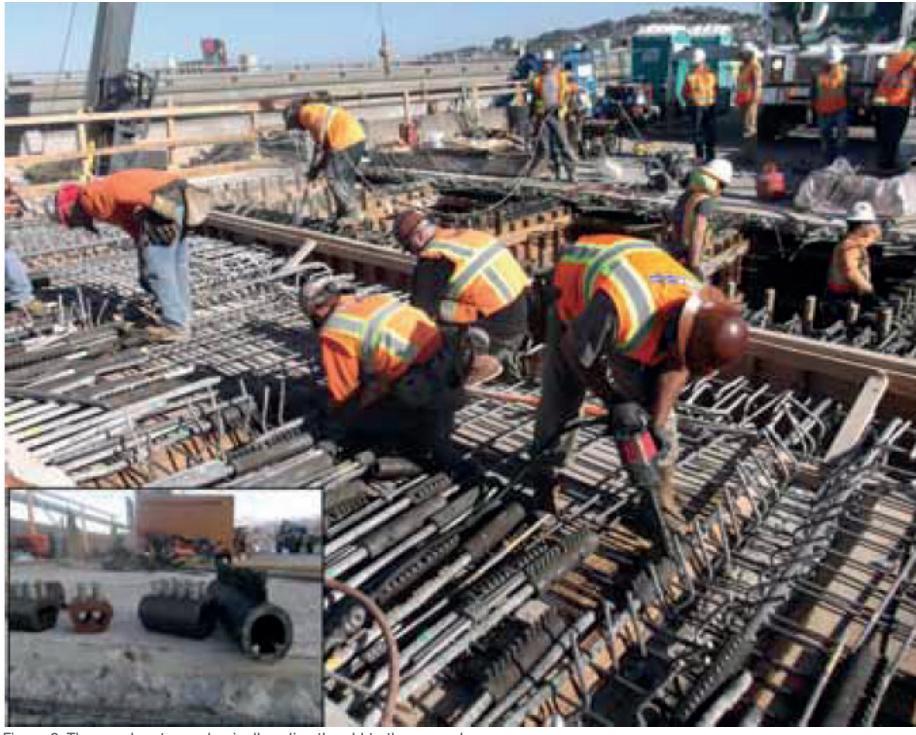
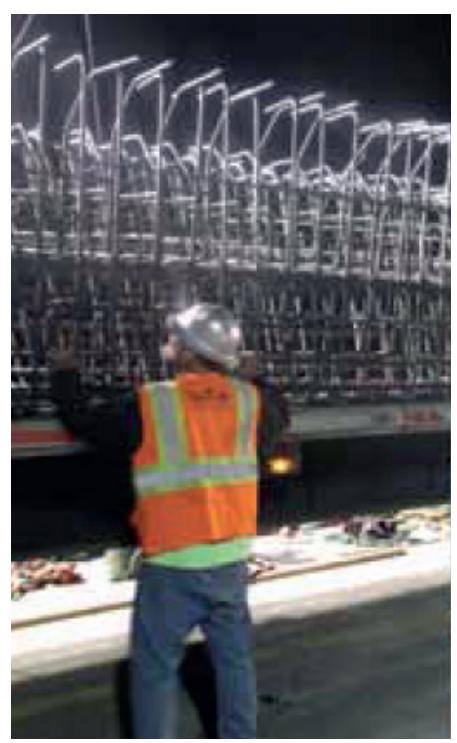
Figure 2. The couplers to mechanically splice the old to the new rebar.

The demolition was performed from the deck and had to be done very carefully and strategically so as not to damage the existing structure that was to remain, including exposed longitudinal reinforcement. Enough existing longitudinal reinforcement needed to remain intact for mechanical staggered splicing to the new construction. The demolition equipment was limited to 1200 ft-lb hydraulic hammers. A CUT Multi Crusher was used to crush and shear through stems (Figure 1). The final removal was hand labor using primarily rivet busters to prevent damage to the portion of the bridge that was to remain. To maintain a clean construction joint, a 1-inch saw cut was made on the entire exterior and interior surface of the superstructure along the construction joint. The entire demolition had a duration of approximately 16 hours.

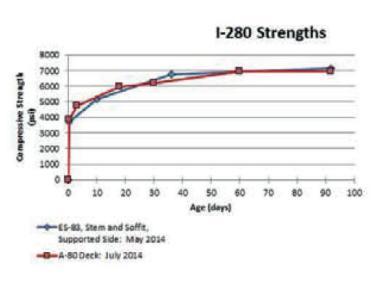
Figure 5. Compressive strength vs. time.

and mixing, and consistent properties of cement, aggregate and admixtures, thus achieving the high degree of quality control confirmed by quality assurance results. Figure 5 shows the strength gain with time up to 3 months.

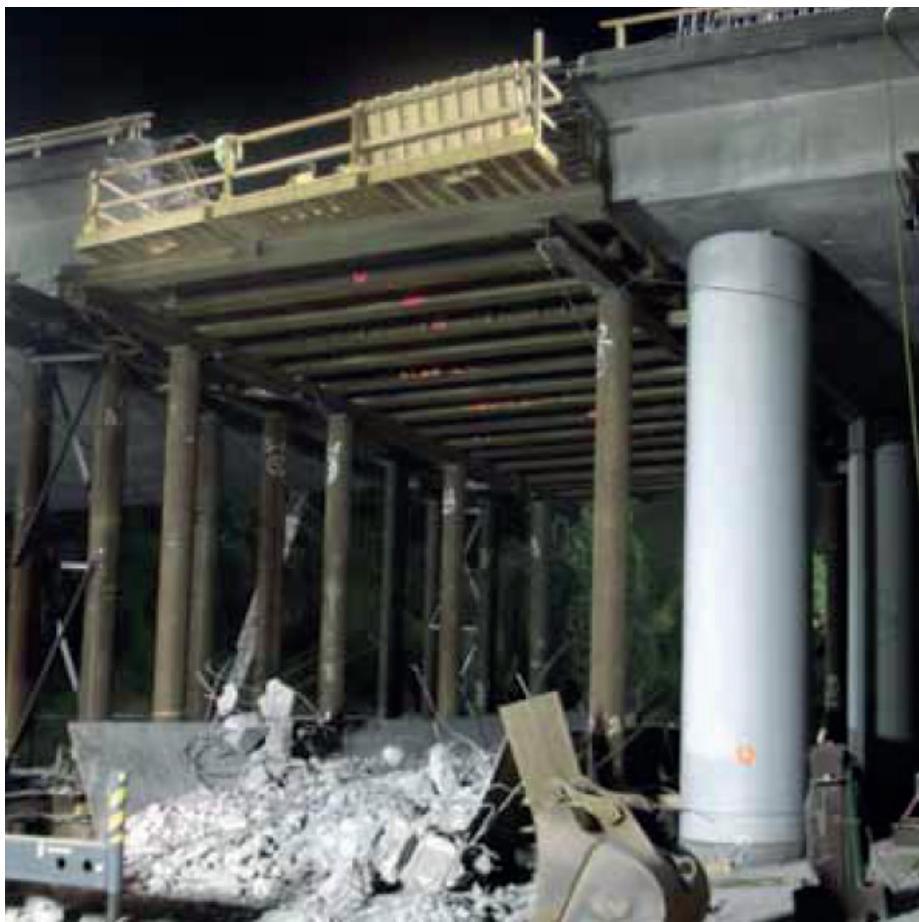
Figure 6. A view of a removed hinge and box from below.
