FAST-SETTING SUCCESS FOR TROPICAL CLIMATES

The key to success often lies in specifying rapid-hardening, durable cement products that are easy to mix and place.

ARTICLE REPRINT The Construction Specifier October 2017

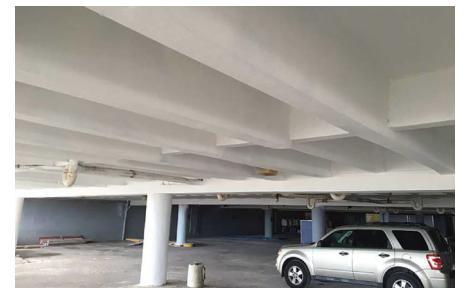
The National University College Arecibo campus sits just 15 m (50 ft) from the Atlantic Ocean, and the winds caused heavy corrosion to the campus parking structure. As a result, the structure was in dire need of structural repairs.

The contractor used high-performance, rapid-hardening cement products to provide full- and partial-depth repairs with rebar replacement for the structure's beams and columns. All materials were one-component mixes, which were combined with water onsite via barrel mixer. The fast-setting materials enabled the contractor to perform the bulk of repairs before daily high-wind conditions set in. Further, because the repair materials can be applied at thicknesses up to 152 mm (6 in.), the crew was able to achieve full depth in a single coat, completing repairs more quickly.

For partial-depth repairs, the crew removed the top third of damaged slabs and replaced it with a corrosion-resistant material. The polymer-modified blend of rapid-hardening cement, additives, and specially graded

The crew's biggest challenge was the need to work around sea breezes and strong ocean winds threatening to blow around the material. For example, while performing partial-depth repairs, the crew mixed and placed the V/O repair material during the early morning hours, when wind conditions were most favorable. It was placed by 9 a.m. each morning, when the wind typically changed directions and grew stronger.

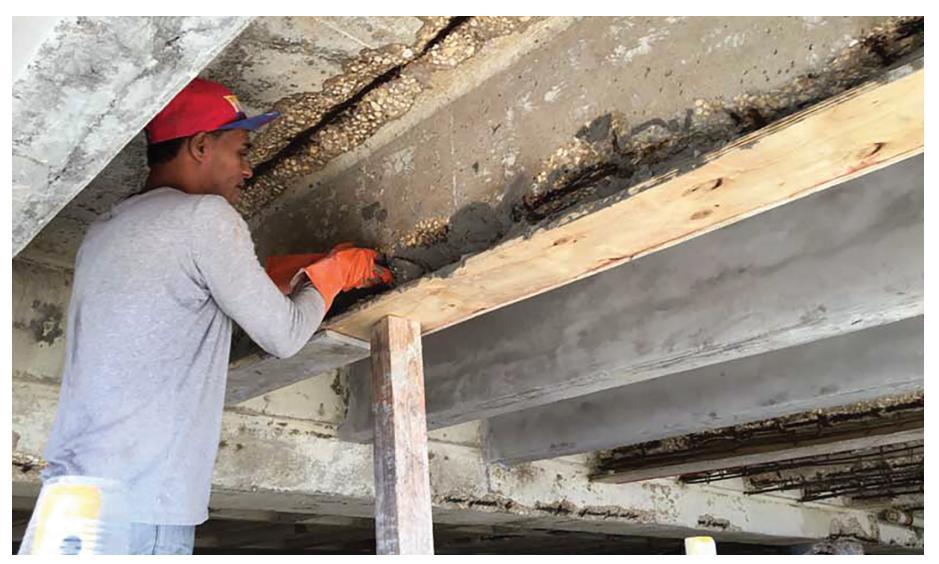
Since the top rebar in areas of the pavement near the toll plaza did not have enough concrete cover, it was attacked by the high concentration of chlorides in the environment. In turn, this caused deep cracks and fragmentation in the concrete. To minimize road closure time, the crew needed a very fast-setting structural mortar with early high strength to perform the partial-depth repairs.

Parts of the pavement required partial-depth repair due to corrosion deterioration and concrete delamination. A rapid-setting cement was selected, as it is a durable solution for time-critical jobs in harsh environments.

A mix especially made for harsh environments was chosen, consisting of rapid-hardening cement, specialty sand, and high-performance additives. An integral, powder-based corrosion-inhibiting additive was introduced to create a protective barrier on the embedded steel that both repels water and reduces chloride migration to the rebar. The crew was able to open all lanes to traffic three hours after repairs were made, which

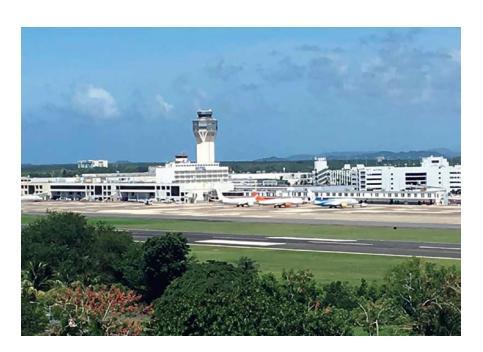
A multipurpose repair mortar known for its rapid structural strength and long-lasting durability in corrosive environments was used for the airport repairs. The surfaces were ready for traffic and most loads within two hours. Photo © Guillermo E. Alvarez Cartañá

Aerostar worked with the contractor to select a repair material capable of meeting the maintenance program's objectives. They chose a multipurpose repair mortar known for its rapid structural strength and longlasting durability in harsh environments. The mix of rapid-hardening cement, specialty sand, and additives can also be extended with coarse aggregate, up to 100 percent by weight. Most importantly, surfaces repaired with the material require only one hour of wet-curing, and are ready for traffic and most loads within two hours.

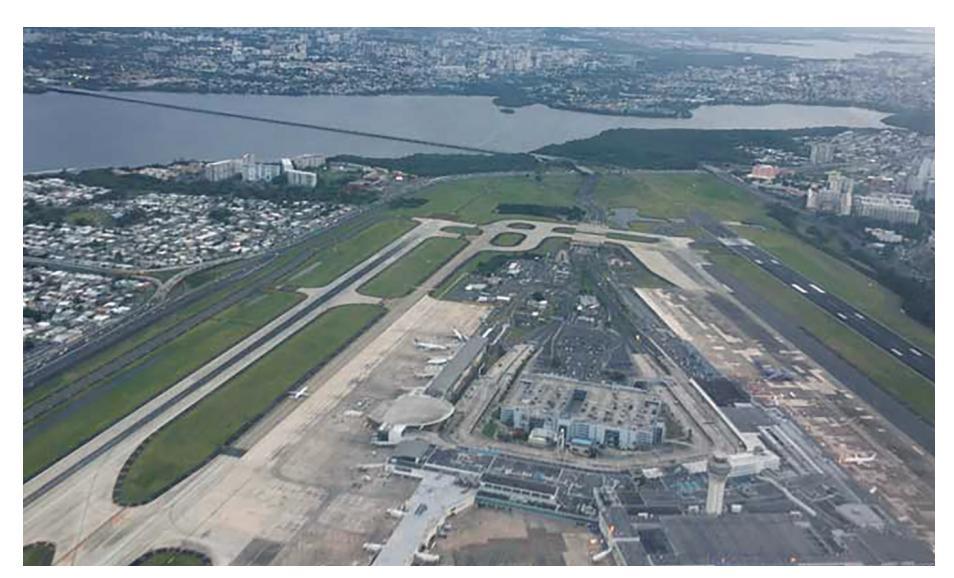
The airport's two runways had taken a fairly understandable beating over the years and eventually began to show signs of wear and tear, including slab fragmentation at curled joints. At least 4.5 m2 (50 sf) of deteriorated concrete surface was identified, with most of the damage located in the apron areas where planes stop to unload and load passengers.

San Juan Luis Muñoz Marín International Airport's two runways had taken an understandable beating over the years, and eventually began to show signs of wear and tear, including slab fragmentation at curled joints. Photo © Santiago Alvarez

In May 2016, Aerostar Airport Holdings, which manages the airport via a publicprivate partnership (P3), embarked on a year-long maintenance program to repair the runways without having to shut them down. The program's success relied on the maintenance crew's ability to quickly perform partial-depth concrete slab and joint repairs and return those repaired portions of runway to service within a two-hour window, so as not to disrupt scheduled flights. Only a fast-setting repair material could make this extremely tight turnaround possible.
