WATERPROOFING WITHOUT MEMBRANE

Forty years after completion, a post-tensioned shrinkage-compensating concrete mat foundation is still solid and watertight

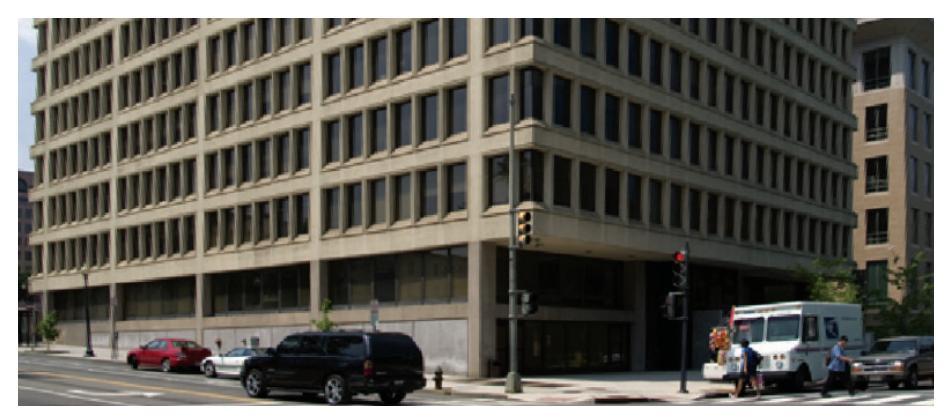
Fig. 1—500 First Street, NW is an eight-story building with two basement levels. Like many sites in the Washington, DC, area, there were significant groundwater issues to contend with in constructing the foundation. Erected in 1967, it was the first building in the city constructed with post-tensioning. (Photo by Steven H. Miller, courtesy of CTS Cement Manufacturing).

The office building at 500 First Street, NW was the first post-tensioned building constructed in Washington, DC. It was designed by Weihe Black & Kerr Architects, Washington, DC. Structural engineering was done by Keith Thornton, then Vice President of T.Y. Lin and Associates and Manager of the firm's New York office. The Lin firm pioneered post-tensioned structural concrete in the U.S. Design documents date from February 1966, and the building was completed in April 1967 (Fig. 1).

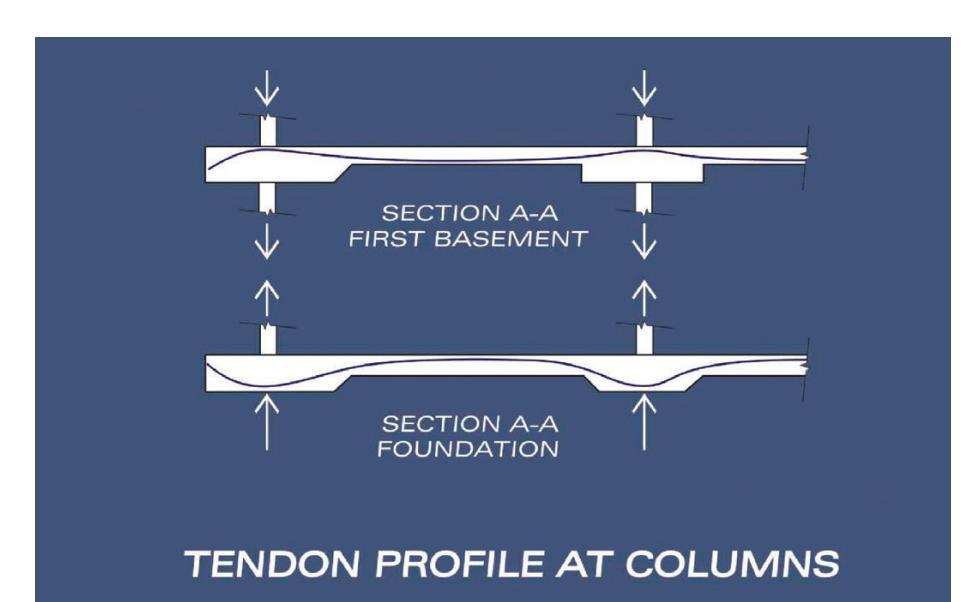
Fig. 2—In the foundation, post-tensioning tendons loop down under the building's load-bearing columns. When stressed, the horizontal tension creates vertical thrust where the tendon dips down. This thrust helps resist the vertical load of the building. In the floor slabs, however, the post-tensioning tendons are at their highest points over load-bearing columns and drape down across the floor spans. When stressed, they provide upward thrust that resists the dead load of the floor, presenting the floor floor scaping across the spans. Building's floor decks are a mere 6 in. (150 mm) thick and span 32 ft (9.8 m). (Illustration courtesy of CTS Cement.)

In the foundation, the tendons loop up and down across the length and breadth of the slab. They dip down under into the drop panels and are at their lowest point—just 3 in. (75 mm) from the bottom of the slab directly underneath the columns. They are at their highest point halfway between the columns. When stressed, the diagonal path of the tendon provides a strong upward thrust component under the columns, helping to balance the load of the superstructure.

Post-tensioning was also used in all floor decks of the building, but there, tendon-placement followed an opposite strategy. Tendons are near the top of the slab thickness just over the columns. They dip down across the span between columns, providing maximum uplift at the center of the span to resist the dead load of the floor (Fig. 2).

This additional strength allowed the floorslab thickness to be reduced to 6 in. (150 mm). The drop panels surrounding the columns add an additional 10 in. (250 mm), for a total deck thickness of only 16 in.

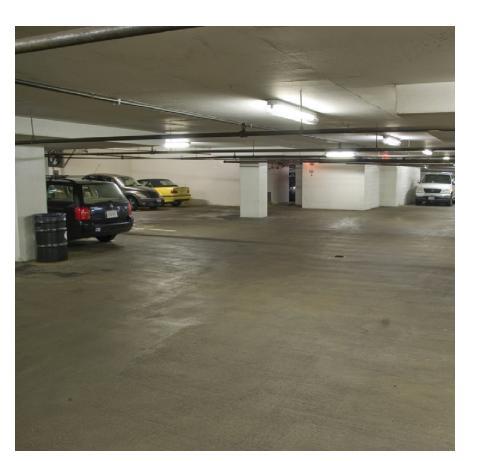
Fig. 3—The floor of the second basement is actually the top surface of the foundation. Forty years after construction, it is crack-free, watertight, and completely dry. The 10 in. (250 mm) thick drop panels of the first basement deck are clearly visible in the ceiling of this photo: they resemble broad soffits surrounding the load-bearing pillars. (Photo by Steven H. Miller, courtesy of CTS Cement Manufacturing.)

basement—the floor of which is the foundation slab—is crack free and does not leak (Fig. 3). The below-grade walls also remain watertight (Fig. 4). The only sign of water damage in the basement is from a roof leak in the elevator shaft.

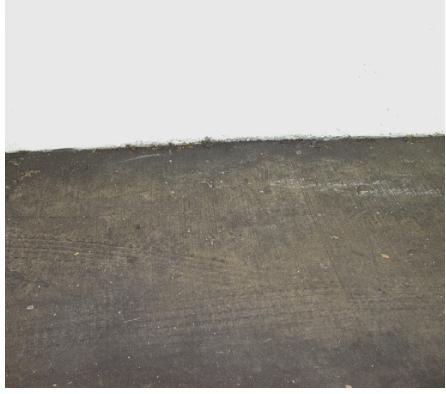
Fig. 4—Even at the meeting point of foundation and basement wall, there is no evidence of cracking or leakage. (Photo by Steven H. Miller, courtesy of CTS Cement Manufacturing).

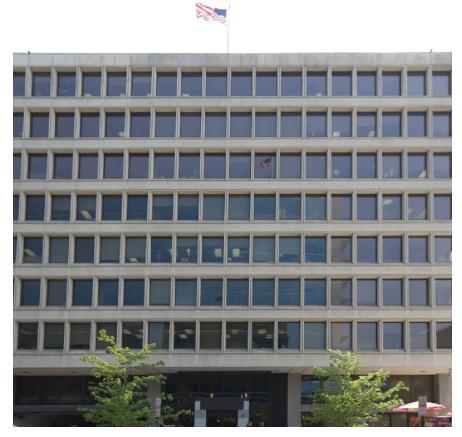
Fig. 5—Forty years later, the building is stable and in excellent condition. The thin deck-slabs made possible by posttensioning allowed the designers to get an extra story into the structure and still stay under the city's absolute height limit. The building is currently occupied by offices of the Federal Bureau of Prisons. (Photo by Steven H. Miller, courtesy of CTS Cement Manufacturing.)

One common source of leakage below grade can occur around the diagonal braces—called rakers—that protrude through the cast concrete walls. Rakers are used as temporary support for the lagging that is placed around the excavation before the foundation is cast. When the concrete walls are placed, the rakers are still in position; they are cut off inside after the walls have cured. They can create stress points that compromise the concrete and cause leaks. There is no evidence, however, of any such leakage at 500 First Street. possibly due to the effective combination of shrinkage-compensating concrete and post-tensioning (Fig. 5).
