BUZZER-BEATER: CREW ASSISTS ON HOOPS ARENA REVAMP

ARTICLE REPRINT

Coatings Pro Mag January 2019

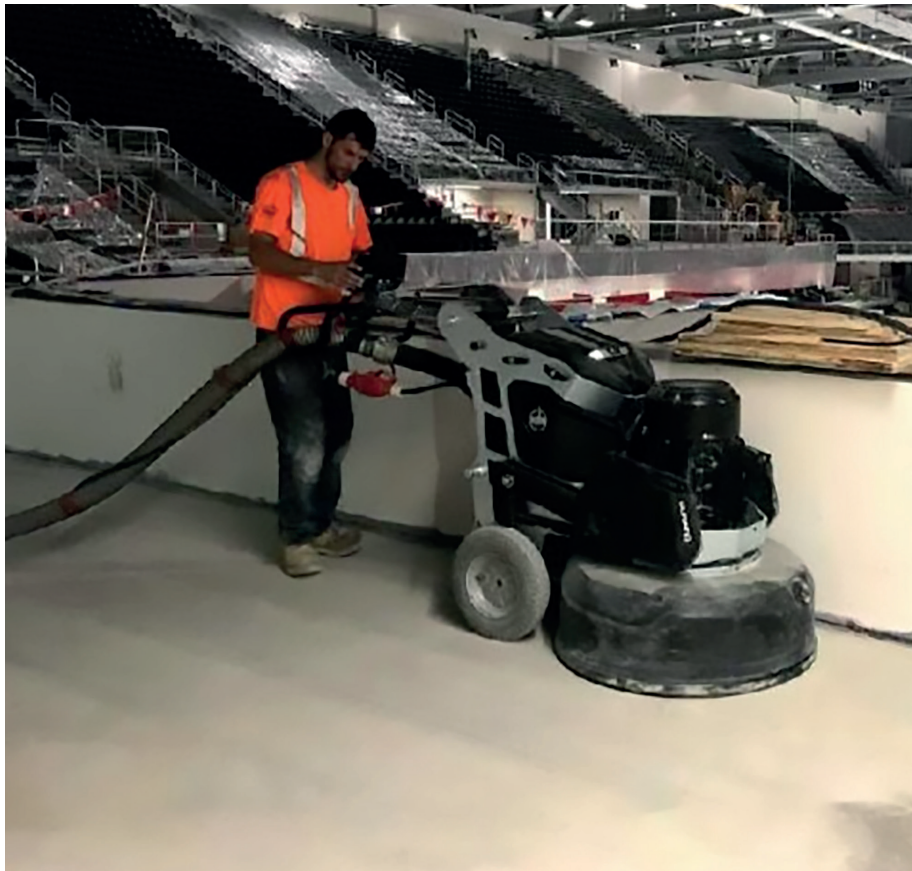
In the concourses, the crew polished the concrete with remote-controlled and hand-held grinders. They filled the joints with polyurea and then finished the concrete with a densifier and protective sealer, both by Prosoco.

The third and last phase involved polishing ~60,000 square feet (5,574.2 m²) of concrete in the concourses and applying the ~25,000 square feet (2,322.6 m²) polished overlay and logo in the main entry areas. Polishing was done to a medium finish utilizing HTC DURATIQ T8/RT8 remote-controlled grinders and 5- and 7-inch (12.7 cm and 17.8 cm) Metabo hand grinders. Joints were filled with Metzger McGuire’s Sal-Pro RS 88 polyurea via a U.S. Saws joint pump before crew members used a pump sprayer to apply Prosoco’s Consolideck LS/CS densifier, capped by Prosoco’s PolishGuard as a penetrating protective sealer.

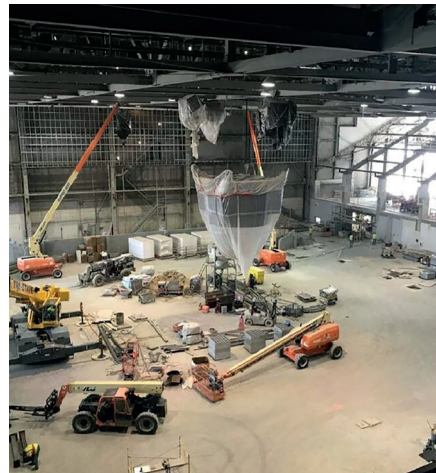
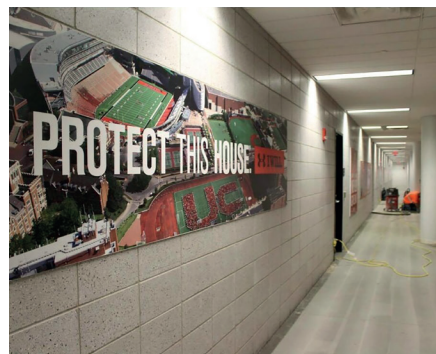
The original job scope for the crew, which averaged 8 to 10 daily workers, included resinous flooring work in concessions, storage areas, locker rooms, and restrooms, along with polishing new and existing concrete in concourses. But the logo overlay increased the complexity, as did another late addition.

“The self-leveling underlayment was not in the original scope,” Kipp said. “In the lower bowl, under the permanent wood basketball court, we completely leveled that floor to get the flatness and level where it needed to be before putting the hardwood floor back on top of it.”

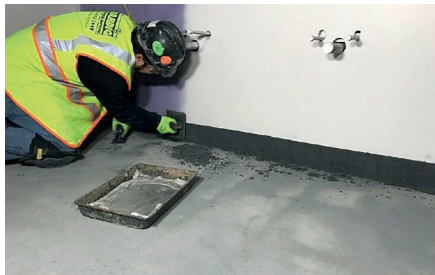
The resinous flooring system by Sika covered concessions, storage areas, locker rooms, and restrooms. After shot blasting the concrete, the crew installed a 4-inch (10.2 cm) integral cove base.

Phase one involved applying 30,000 square feet (2,787.1 m²) of resinous flooring. For this, crew members shot blasted existing and new concrete using a Blastrac 1-10D to achieve a Concrete Surface Profile (CSP) 4-6, required to install the Sika Decoflake UEF system with 4 inches (10.2 cm) of integral cove base.

For that system, the initial layer was the Sikafloor-22 NA PurCem urethane cement base-coat – applied at approximately 0.25 inch (0.64 cm) using a CAM gage rake from Seymour Midwest—with Sikadur-509 aggregate broadcast to excess. Then, the sikafloor 264 100-percent solids epoxy primer was applied in black at an average of 12 mils (304.8 microns) using an 18-inch (45.7 cm) Midwest Rake squeegee from Seymour Midwest, with a 0.25-inch (0.64 cm) custom flake broadcast to excess. Next, the clear Sikafloor 217 was squeegeed as the grout coat as an average of 16 mils (406.4 microns), while the Sikafloor 510 LPL polyaspartic served as the topcoat at an average of 5 mils (127 microns), with Sika’s Barefoot 20 aggregate added for non-skid qualities.

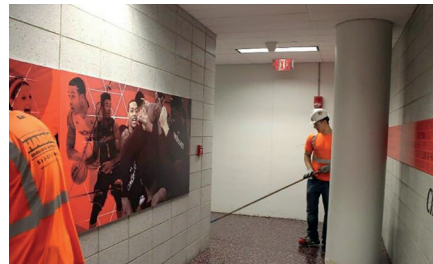
The crew covered various aspects of safety, including stretch and flex exercise, toolbox talks, and personal protective equipment (PPE). Because of new silica standards, the crew prepped with dustless shrouds and vacuums.

Hard hats, safety glasses, high-visibility vests or shirts, steel-toed boots, and cut-resistant gloves were worn at all times as personal protective equipment (PPE). For silica compliance, extra PPE included wearing 3M's disposable N95 particulate respirators with dust masks; using dustless shrouds and vacuums; and wearing face shields when grinding or chipping. Each morning, crew members went through stretch and flex exercises and toolbox talks to analyze potential hazards.

- Completed stretch/flex exercises, hazard analysis, and toolbox talks
- Wore hard hats, safety glasses, high-visibility vest or shirts, steel-toed boots, and cut-resistant gloves at all times
- Wore 3M’s disposable N95 particulate respirators with dust masks, used dustless shrouds and vacuums, and wore face shields when grinding or chipping

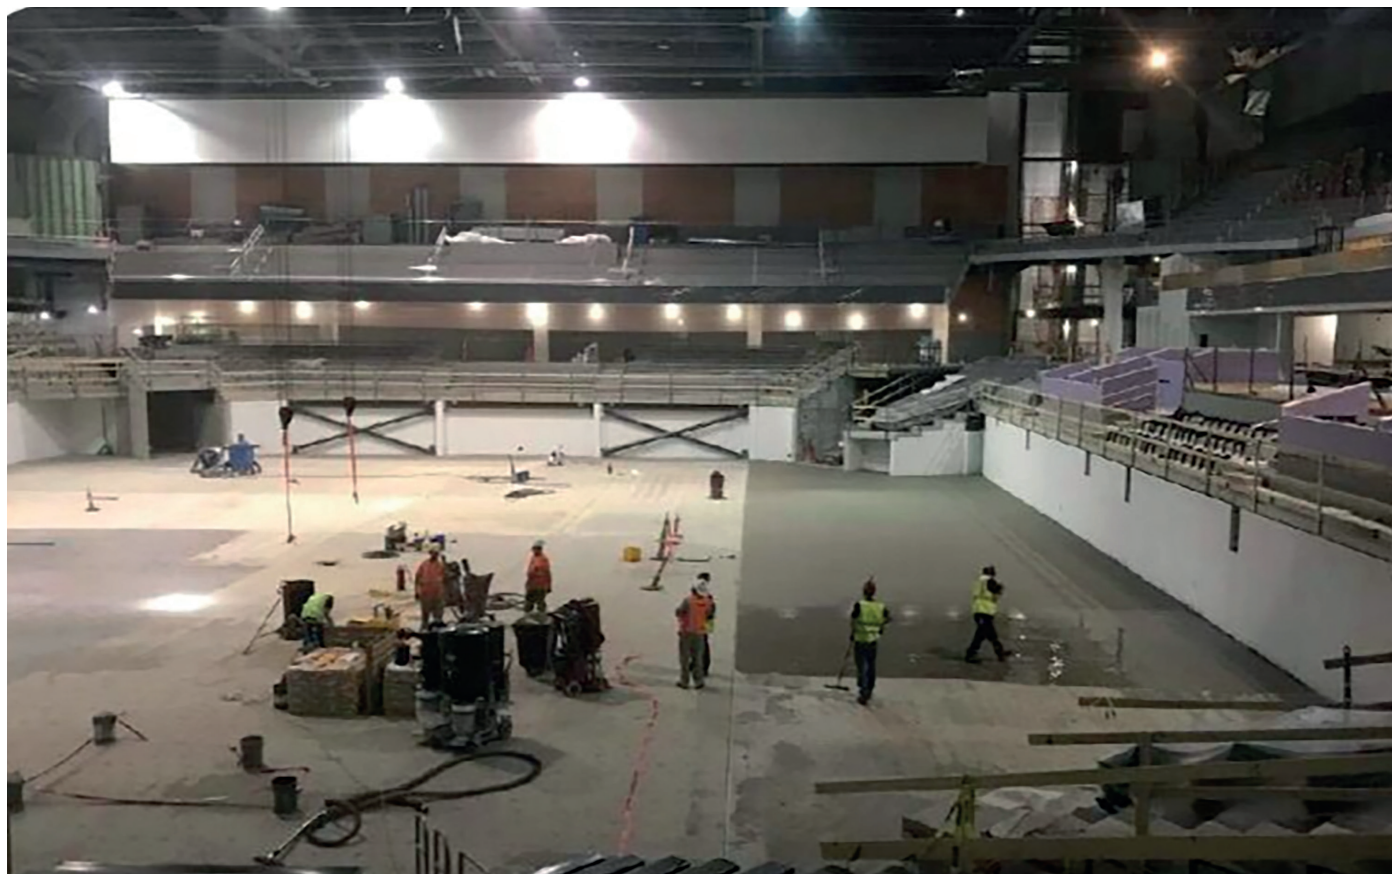
Under the basketball court, the crew used a thermal laser to map and achieve proper flatness. Then, they used scarifiers, scalars, and brush hammers before applying the self-leveling underlayment with gage rakes.

Meanwhile, phase two encompassed the application of 35,000 square feet (3,251.6 m²) of self-leveling underlayment beneath the wood court. The crew first used a thermal laser to create a heat map of the floor’s topography. Specifications called for a FF 50 level of floor flatness as defined by the ASTM E1155 standard, and to get there, the crew needed to know specifics on the degree of preparation required for each area of the floor. After prepping the surface, crew members then applied the Sika Level-125 topping using the CAM gage rake.

“It was thermal heat scanned so that we could understand the peaks and valleys of the floor,” Kipp said. “We then did a lot of scarifying, scaling, and bush hammering to take the high spots down, then we put our topping in. Anywhere from an eighth of an inch [3.2 mm] up to one and a quarter inch

[31.8 mm] is the range that it took to make that floor flat.”

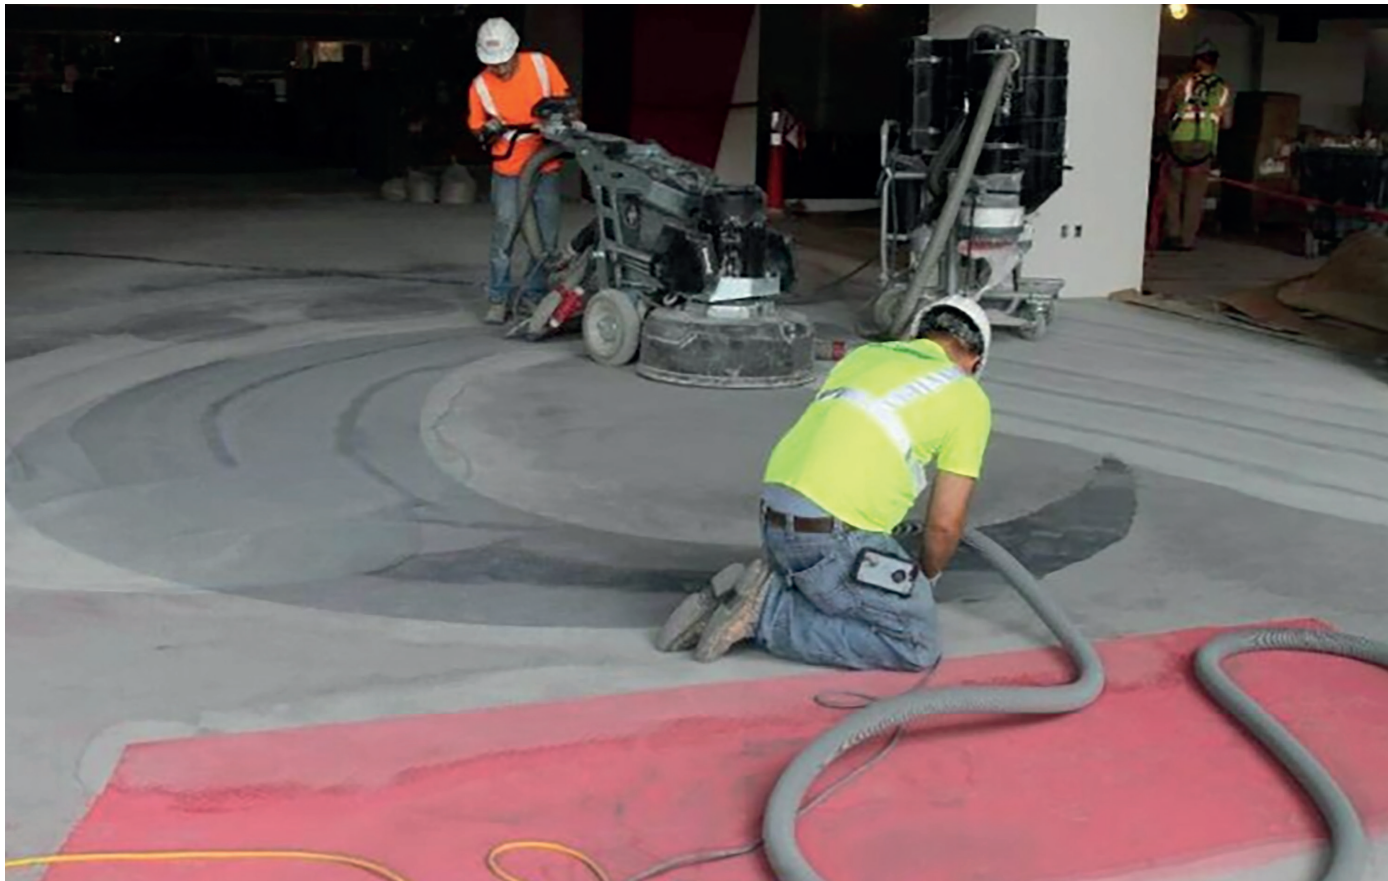
To apply the logo, which had to be developed on a waterjet, the crew shot blasted the concrete before applying a system by CTS Cement and densifier from Prosoco. It was sealed, too.

For the overlay and logo, all areas were prepped to a CSP 6 profile by shotblasting with the Blastrac 1-10D and running HTC Ravager series bush hammers with a DURATIQ RT8 grinder. All areas were squeegeed with a CTS Rapid Set® TXP Epoxy Primer at an average of 12 mils (304.8 microns) and broadcast to excess with 20/40 mesh sand.

Next, the CTS Rapid Set® TRU PC high-flow topping was applied at 0.5 inch (1.3 cm) using the CAM gage rake. All TRU PC was mixed in CS Unitec’s HIPPO Mixers and transported in CS Unitec’s Pelican Carts before polishing via diamond tooling from HTC and Runyon Surface Prep. The area was densified with Prosoco LS/CS and sealed with PolishGuard.

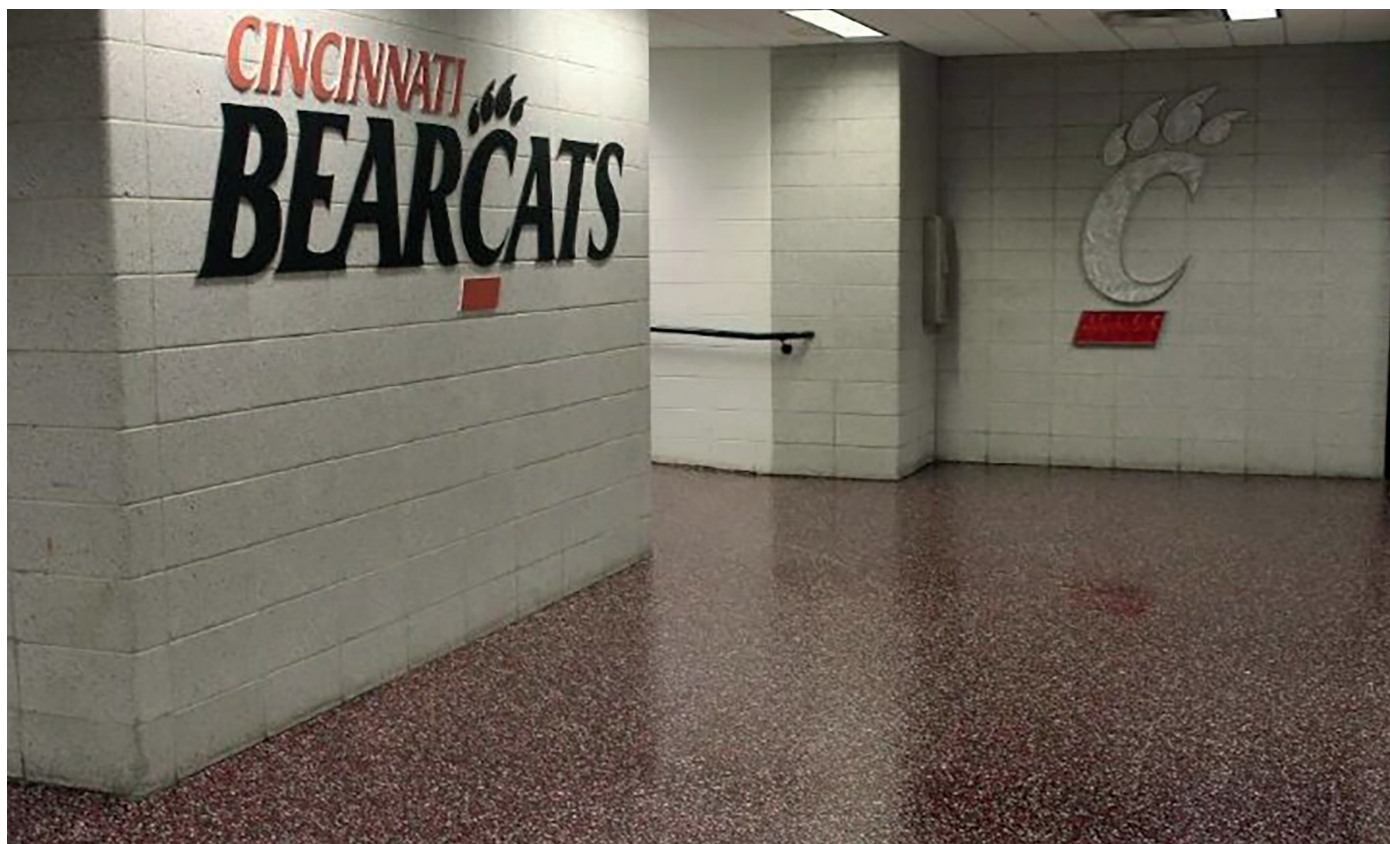
In total, the new and existing concrete covered 150,000 square feet (13,935.5 m²). "It's something we can see and be proud of," said Kevin Kipp, estimator and senior project manager at Hardig.

The University of Cincinnati logo proved to be a challenge for Hardig Industrial, but they found the winning formula. The crew was tasked with finding an overlay material to make a 30-year-old slab look new. In addition to that, it needed to be integrally colored and polished to a high shine to bring the University of Cincinnati logo to life. It would also be expected to remain durable in a high traffic environment for years to come.
