OVERNIGHT POTHOLE REPAIRS ALLOW EL PASO TO PUT TRAFFIC ON I-10 QUICKLY

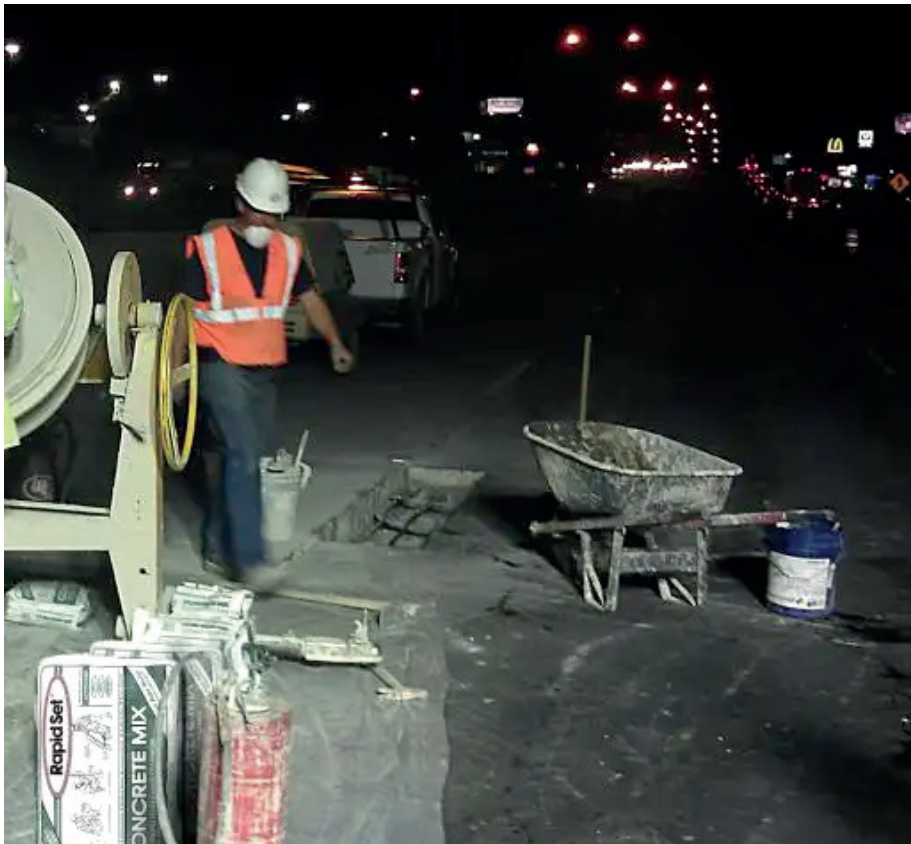
The repair was needed because the potholes were getting deeper, and to avoid a total tear out and reconstruction of the highway, the decision was made to repair each hole.

With so many people in the El Paso area, road repair is a great concern. On I-10, approximately 7 to 8 miles of freeway needed potholes repaired. The repair was needed because the potholes were getting deeper, and to avoid a total tear out and reconstruction of the highway, the decision was made to repair each hole. Rapid Set Concrete Mix was chosen for its high early strength, so repairs could be made overnight and traffic could be allowed on the roadways within a short period of time. The concrete mix is well known for its versatility and high performance. It gains structural strength in one hour, has superior durability and has virtually no shrinkage.

challenge—having repairs complete and the lanes open for traffic by 6 a.m. each morning. While making the repairs in the 70°F to 80°F temperatures, one of the techniques employed to help with quick cure was the use of curing blankets. The repairs ranged from 2 to 4 ft wide and long and approximately 6 in. deep. The potholes were cut back to create a clean edge all around, 6 in. deep. Allen Concrete completed three to four repairs each night using six to eight pallets of concrete mix. The mixing technique involved a concrete mixer, and by the end, approximately 18,000 total bags were used. After placement, the concrete was finished using a trowel/broom finish.
