## PROJECT BRIEF

## VILLA RICA POST OFFICE

Floor resurfacing

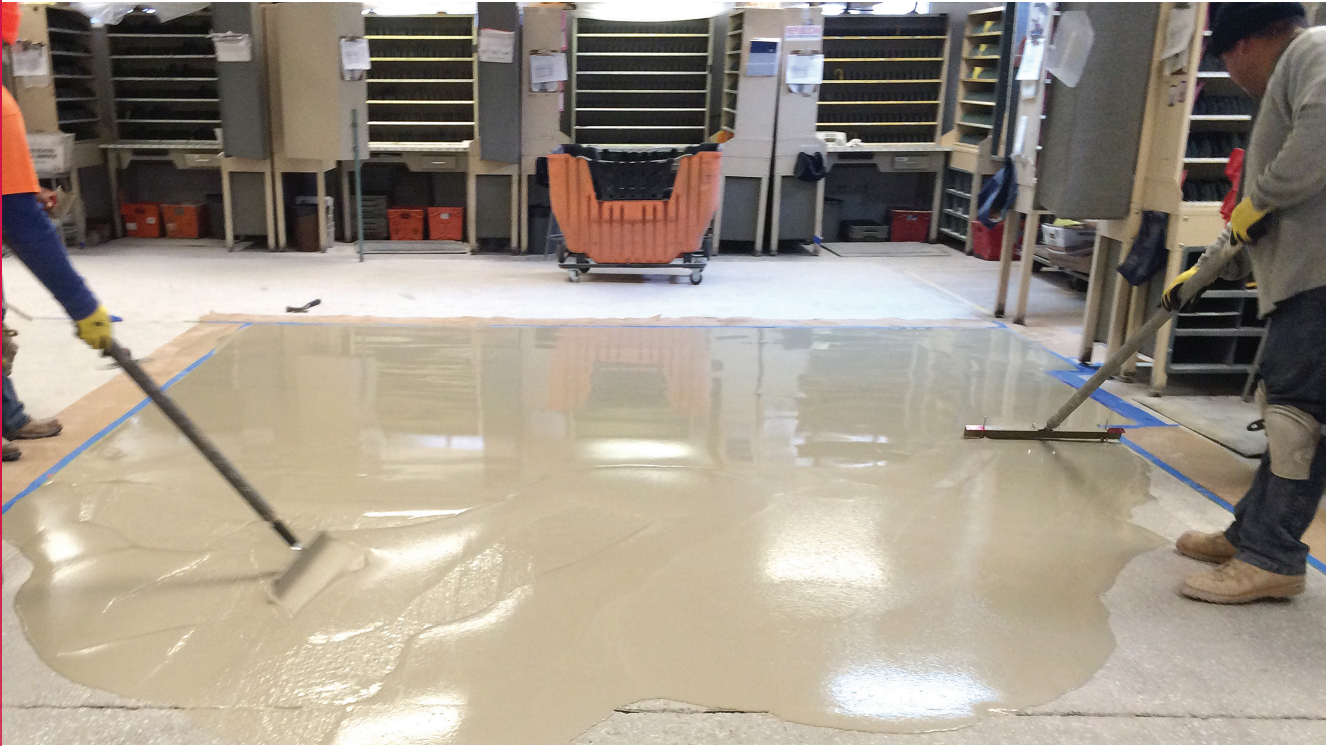
A delaminating, uneven floor was creating difficulties for post office employees as they pushed heavy carts of mail through the distribution center of the Villa Rica, Georgia branch. Additionally, chalking and powder on the slab surface (known as dusting) was a problem. Concrete that is dusting is easily scratched and damaged.

To repair the weakened surface, a TRU Self-Leveling surface was installed. Because the Post Office had to maintain continual operation, the pour was done in six separate sections, with four bags of TRU mixed at a time in a Hippo Mixer. Three hundred bags of product were used in all. The floor was finished using a gauge rake and TRU Self-Leveling Spiked Roller. Acrylic Primer was used underneath to improve the adhesion of TRU Self Leveling. The finished surface provided the Post Office with a flat floor that no longer had a dusting problem.
