PARKING GARAGE REPAIR YIELDS A HIGHLY DURABLE FINISH

PROJECT PROFILE

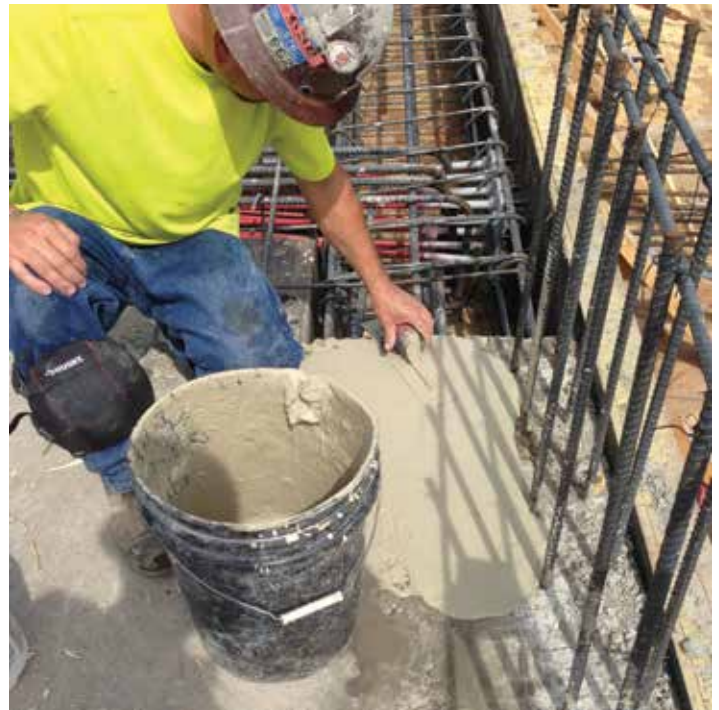
The crew mixes a trial batch to test the color of the mix, to ensure the right amount of the Rapid Set® Dark additive is used to match the repairs to the concrete.

The contractor used more than 70 bags of product (one 55-pound bag yields approximately 0.5 cubic feet) and added Rapid Set® Dark to match the color of the new concrete to the existing slab. The Rapid Set Dark additive darkens the color of concrete and

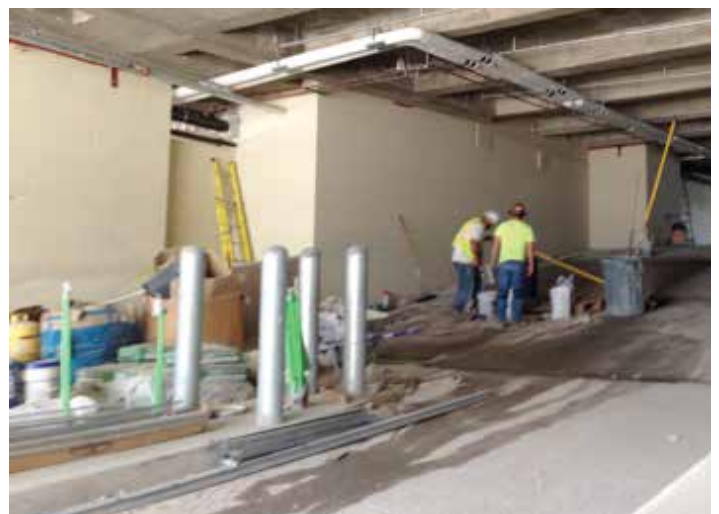
A crew member applies a scrub coat. This method is used to improve adhesion.

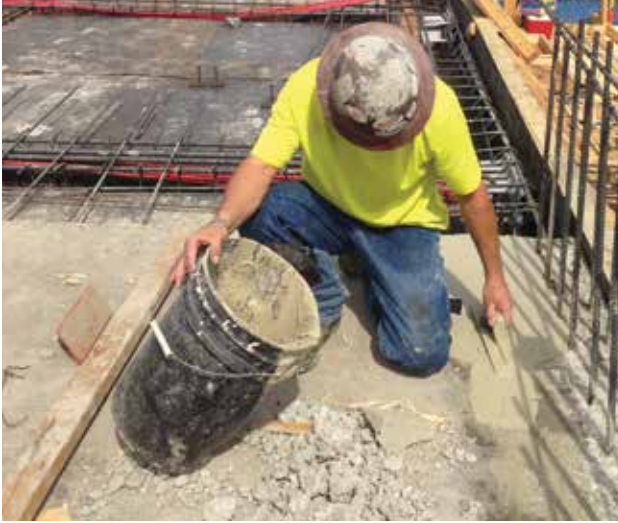
Working Rapid Set® Cement All® deep inside the pores increases adhesion and prevents delamination.

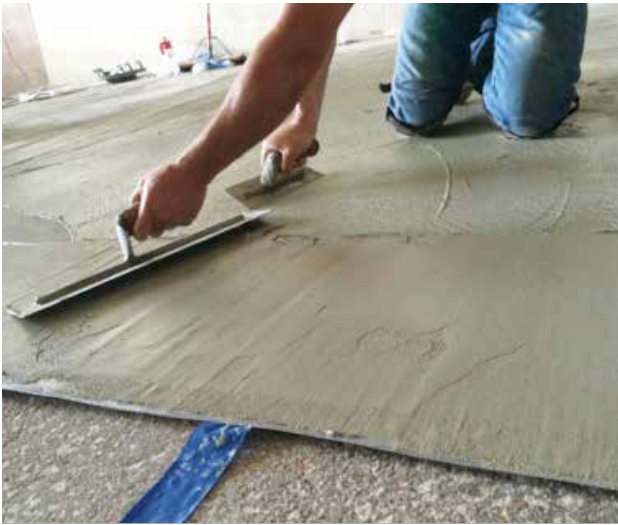
A crew member builds Cement All to the desired thickness of ¼ inch.

First, crew members used a scarifying machine to prep the areas to be repaired. They then vacuumed and washed the slab thoroughly, and saturated it with iced water. Ice water was used to lower the hot ambient conditions experienced on the slab. Next, they installed Cement All by trowel at ½-inch depth.

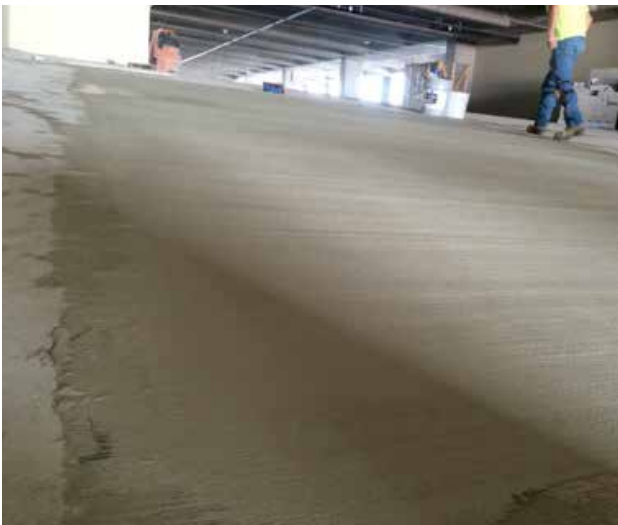
A sponge rubber float was used to apply a broom-like finish.

Querrey Concrete water-cured the repaired areas. The subcontractor then went over the surface with a sponge float before applying a broom finish. A relatively new technique, the sponge float brings up the sand to get a better and rougher broom finish.
