Rapid Set® Concrete Mix, John Deere Distribution Center (McDonough, GA)

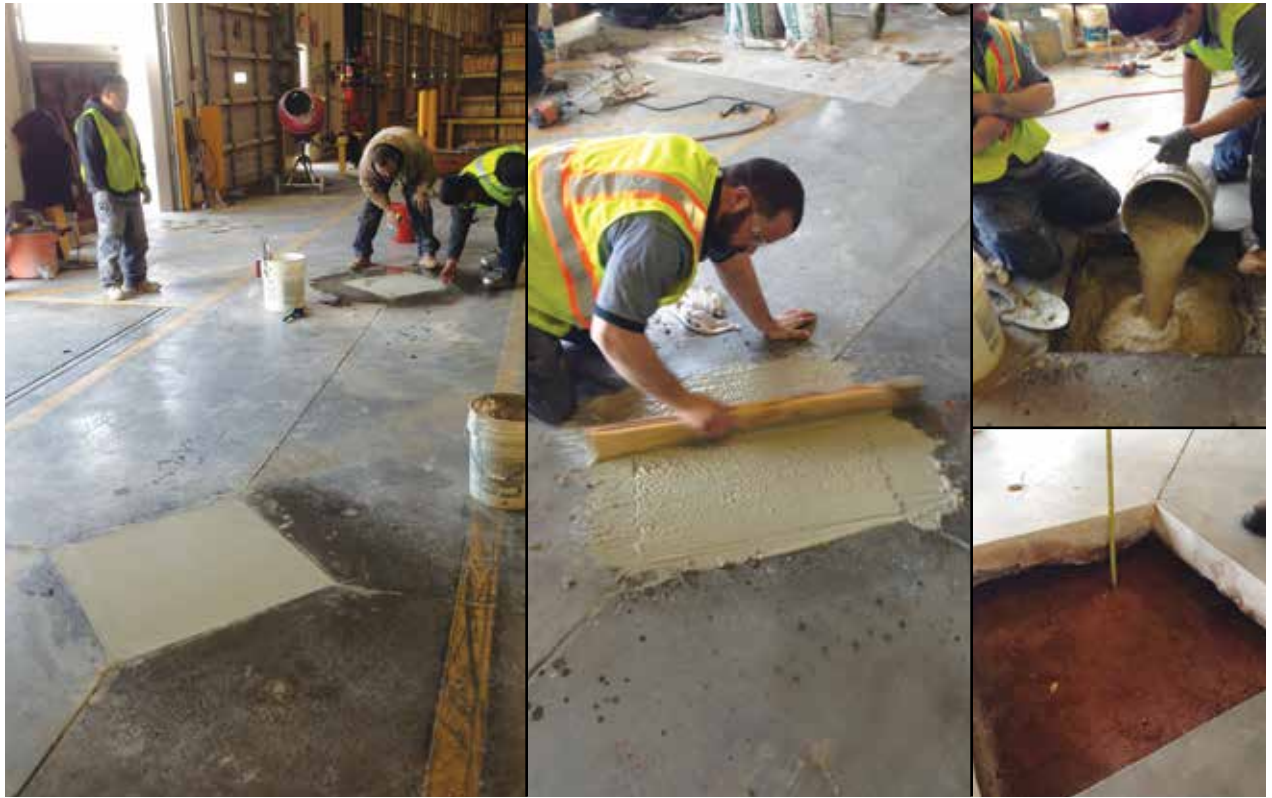
The McDonough distribution center's concrete floor had become uneven over time, with large hollow areas (holes) forming where joints met. However, because the business of getting needed parts to customers could not be disrupted, repairs had to be done quickly—and during limited time frames each day.

To make the floor level again, Engineered Solutions of Georgia, based in Marietta, had to fill 64 holes in the slab. Because reducing downtime was crucial, the contractor used Rapid Set® Concrete Mix to fill the holes. This concrete repair and restoration product sets in 15 minutes and is ready for traffic in one hour.

For this repair project, the crew repaired each hole by first cutting out a 2x2x1-foot section of slab surrounding it and then removing six inches of dirt around and underneath the section. They used 10 bags of Concrete Mix per hole (one 60-pound bag yields approximately 0.5 cubic feet), which resulted in 640 bags for the entire floor. They mixed the product with water in a five-gallon bucket using a heavy-duty ½-inch drill and mixing paddle.

The repaired areas were water-cured, and then finished with a steel trowel. From start to finish, it took just a little more than a week to level the existing floor and put the distribution center back in business. A rapid turnaround resulted in another very happy owner.
